ENCLOSURE 25

33
ENCLOSURE (1)

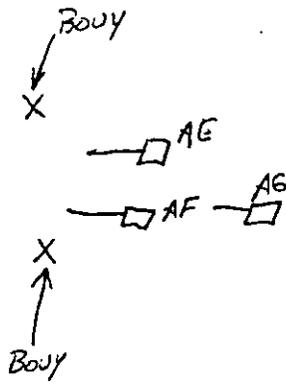
SURFACE PICTURE AT APPROXIMATELY 0500
TO THE BEST OF MY KNOWLEDGE.

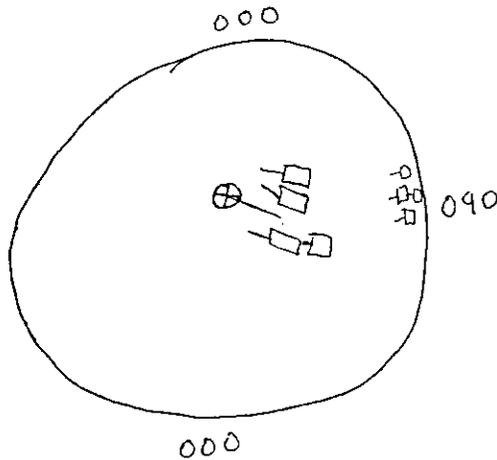
2-5 min before collision
