USS RANGER [CVA-61]
FPO SAN FRANCISCO 96601

Subj: Damage (possible sabotage) in Engineering Spaces of
USS RANGER (CVA 61); supplemental investigation of

- From: Commander Carrier Division THREE
 To: Commander Naval Air Force, U.S. Pacific Fleet
- Subj: Damage (possible sabotage) in Engineering Spaces of USS RANGER (CVA 61); supplemental investigation of
- Ref: (a) COMCARDIV THREE ltr ser 023 of 18 Jul 1972
 (b) NAVSHIPS Technical Manual
 (c) NAVINSERVO Report Control #07-08-72N12-AL77-6 UNA of 2 Aug 1972 (NOTAL)
- Encl: (1) Summary of supplemental unsworn statement of LCDR [redacted], USN
 (2) Summary of supplemental unsworn statement of CDR [redacted], USN
 (3) Summary of supplemental unsworn statement of CAPT [redacted], USN
 (4) Charge Sheet in case of [redacted], dated 2 Aug 1972, with Additional Charge Sheet dated 23 Aug 1972
 (5) Summary of supplemental unsworn statement of CDR [redacted], USN
 (6) USS RANGER INST 5500.2A of 11 Aug 1972
 (7) NISO Report ser 827 of 7 Aug 1972

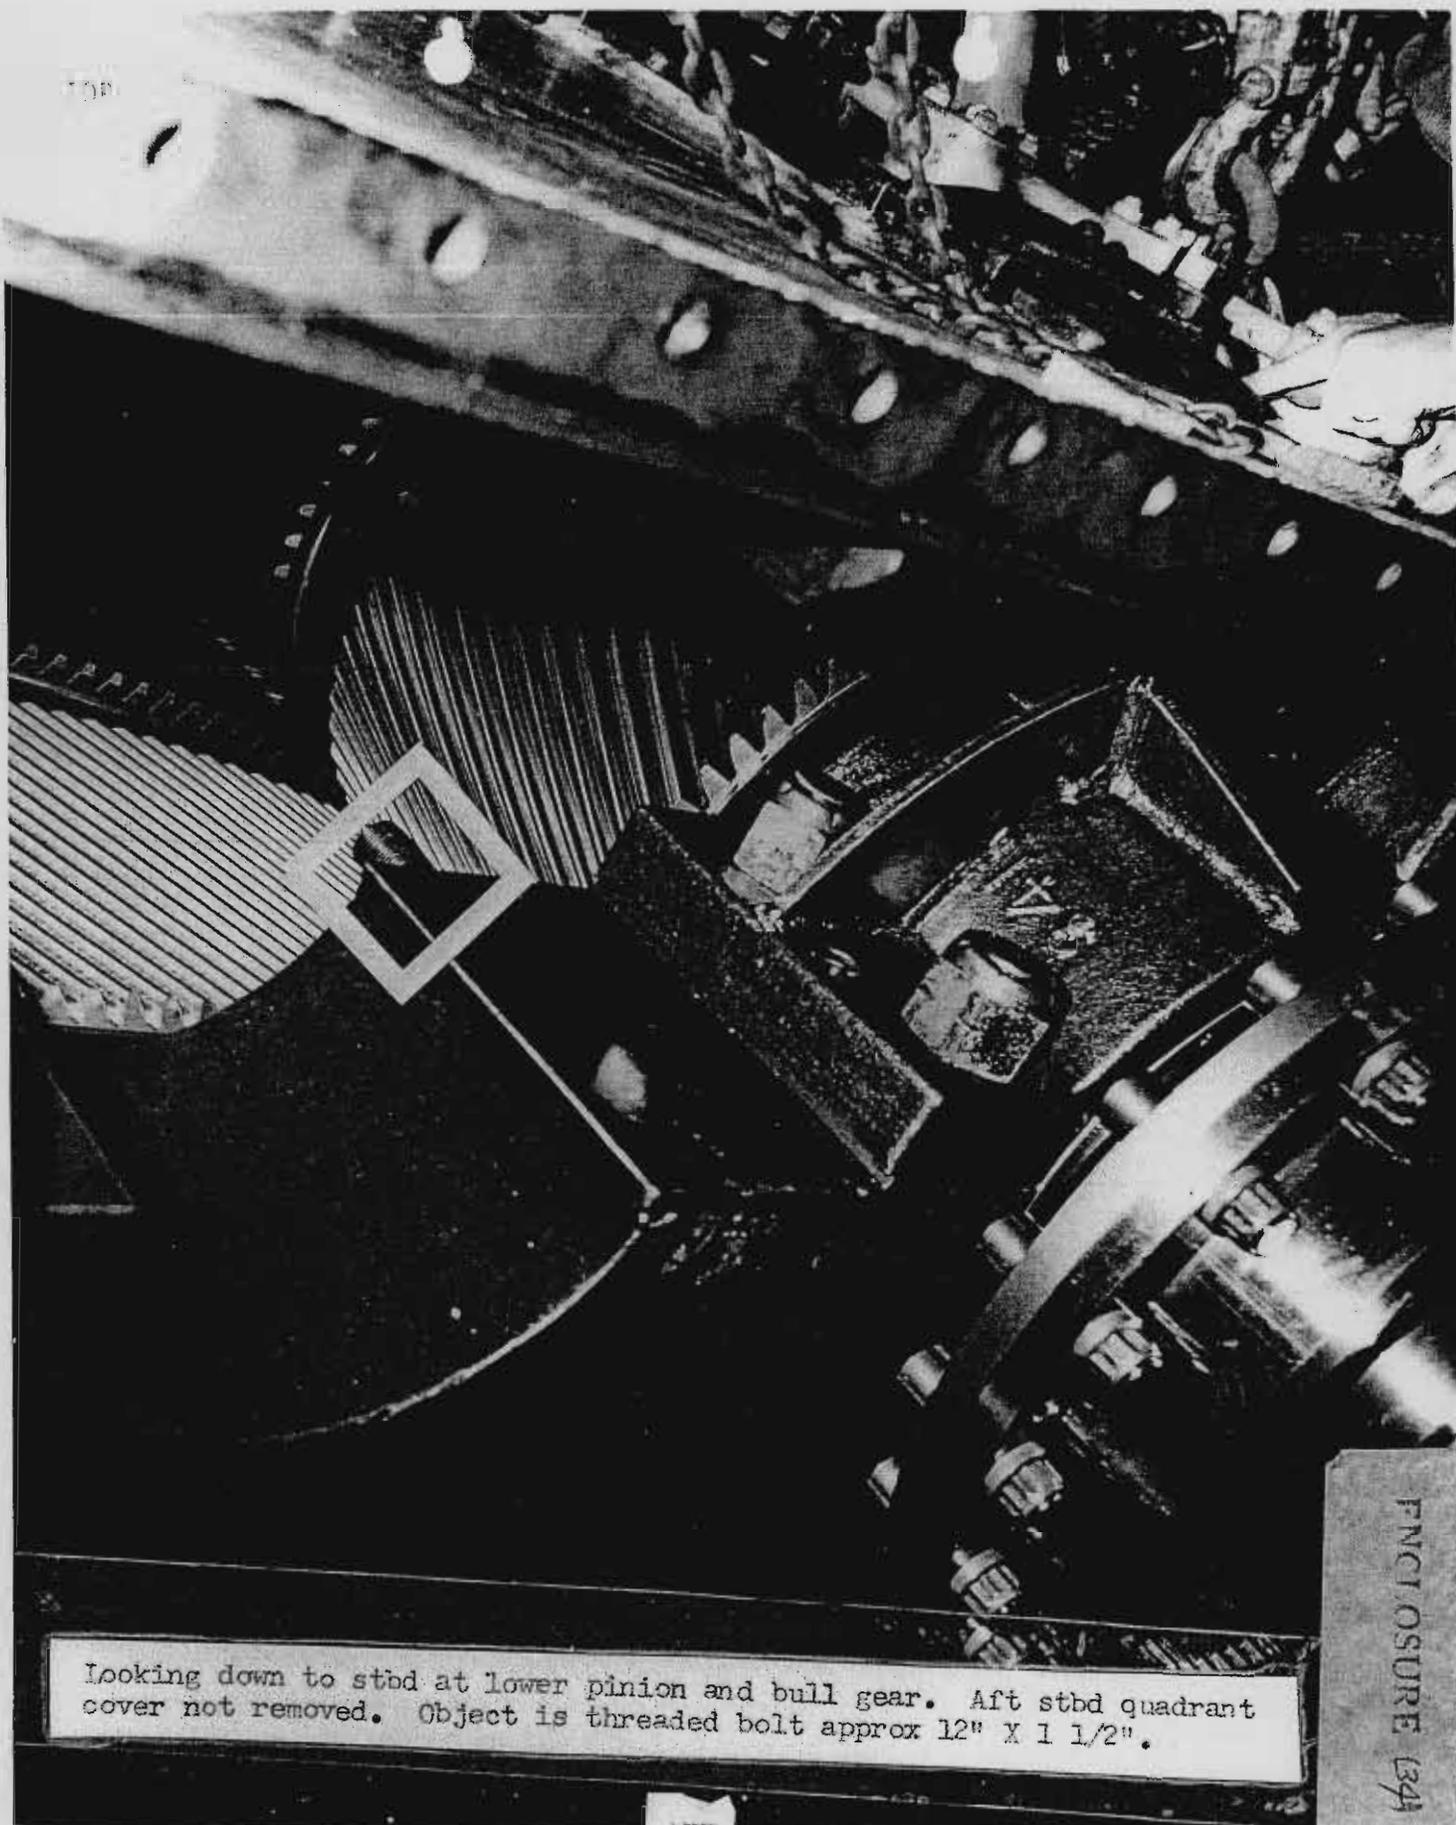
ENCLOSURE 134

Looking down to stbd at lower pinion and bull gear. Aft stbd quadrant cover not removed. Object is threaded bolt approx 12" X 1 1/2".

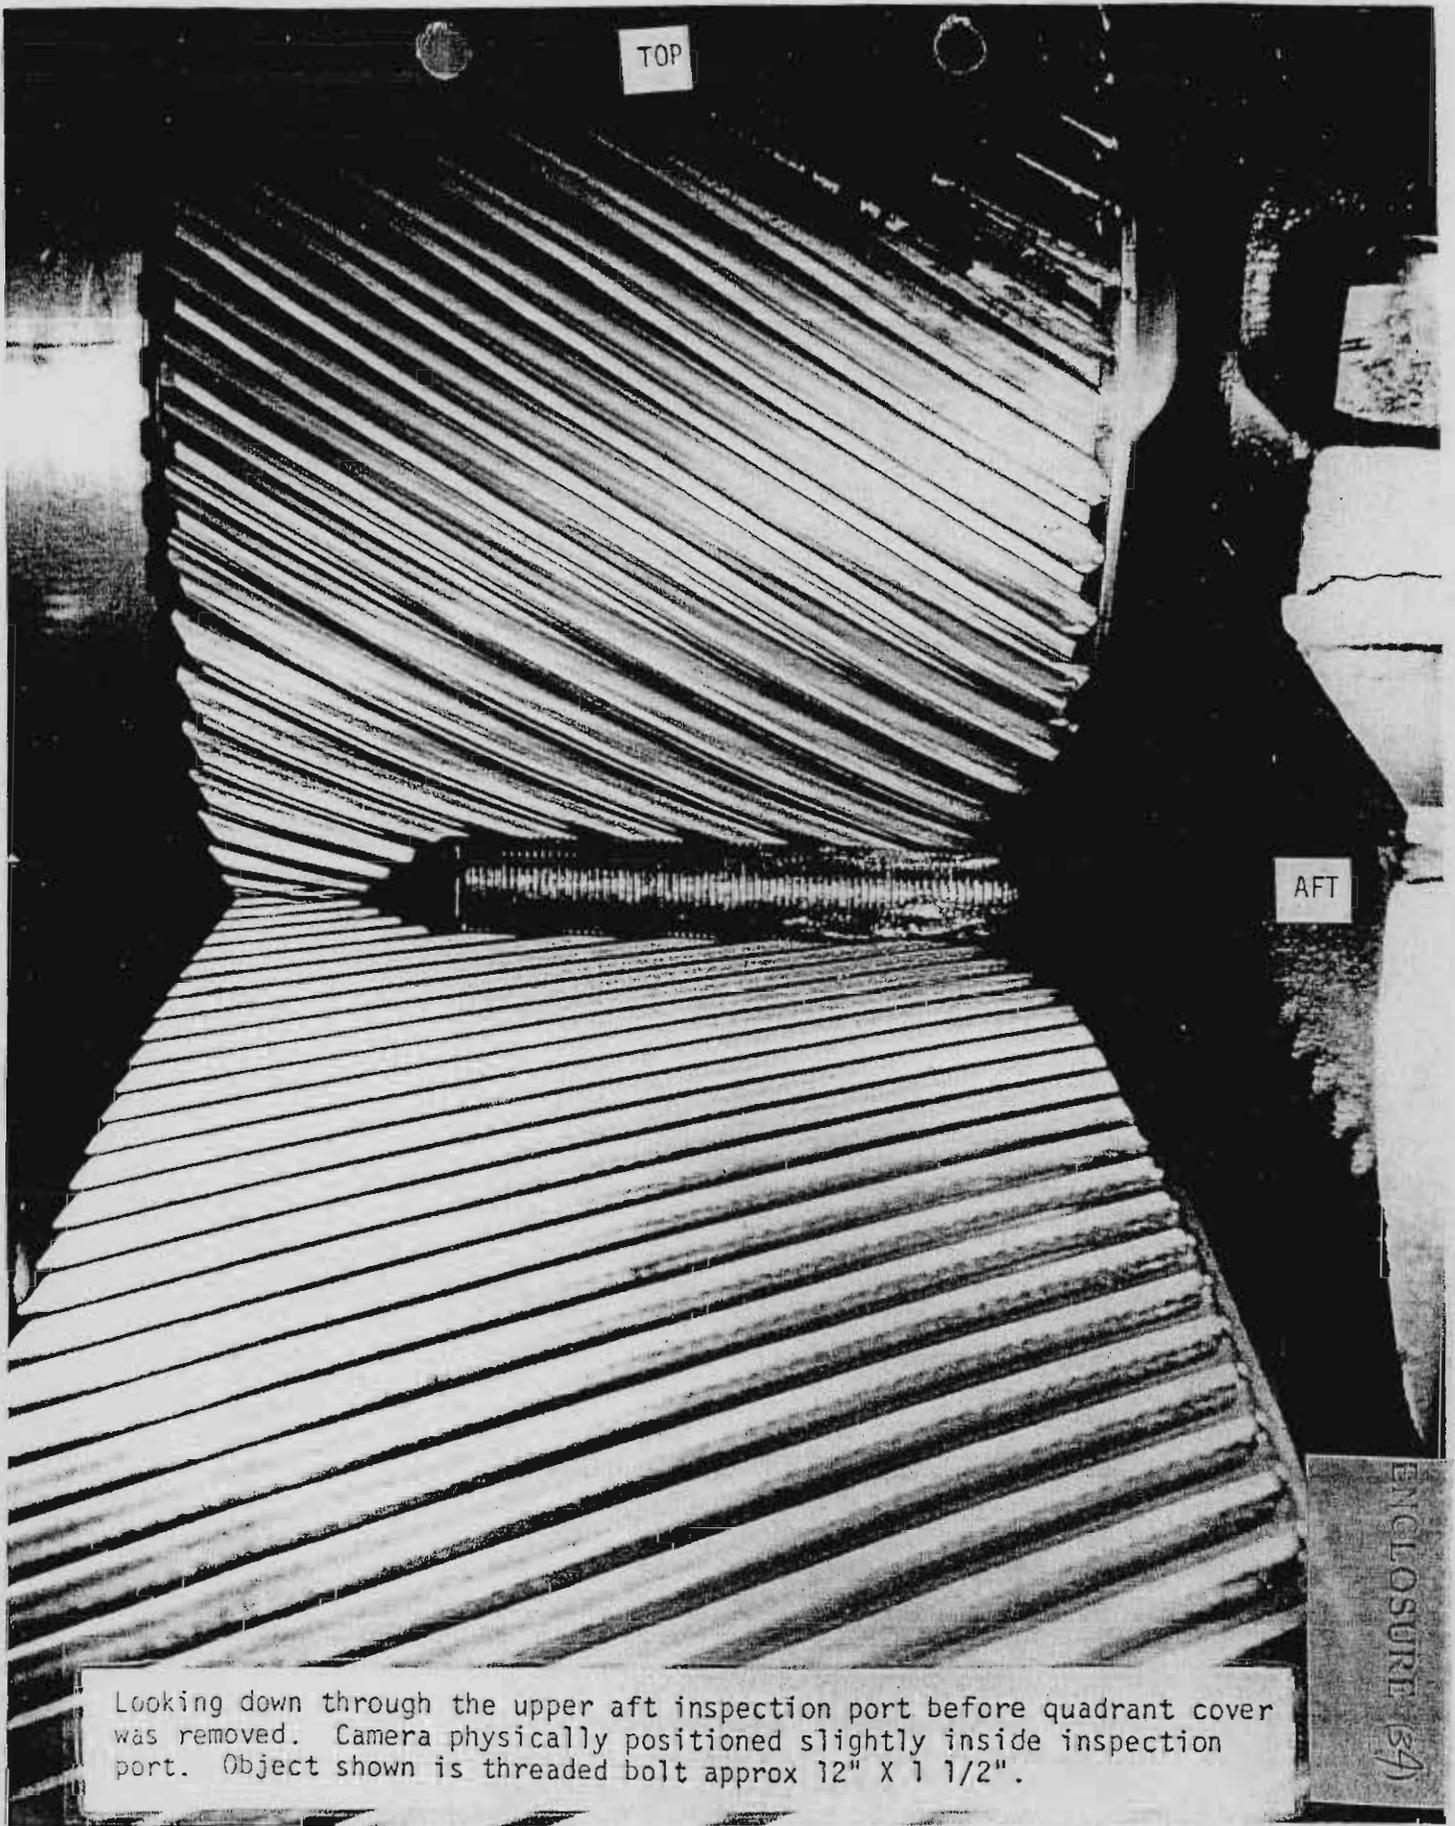
ENCLOSURE (34)

Looking down through the upper aft inspection port before quadrant cover was removed. Camera physically positioned slightly inside inspection port. Object shown is threaded bolt approx 12" X 1 1/2".

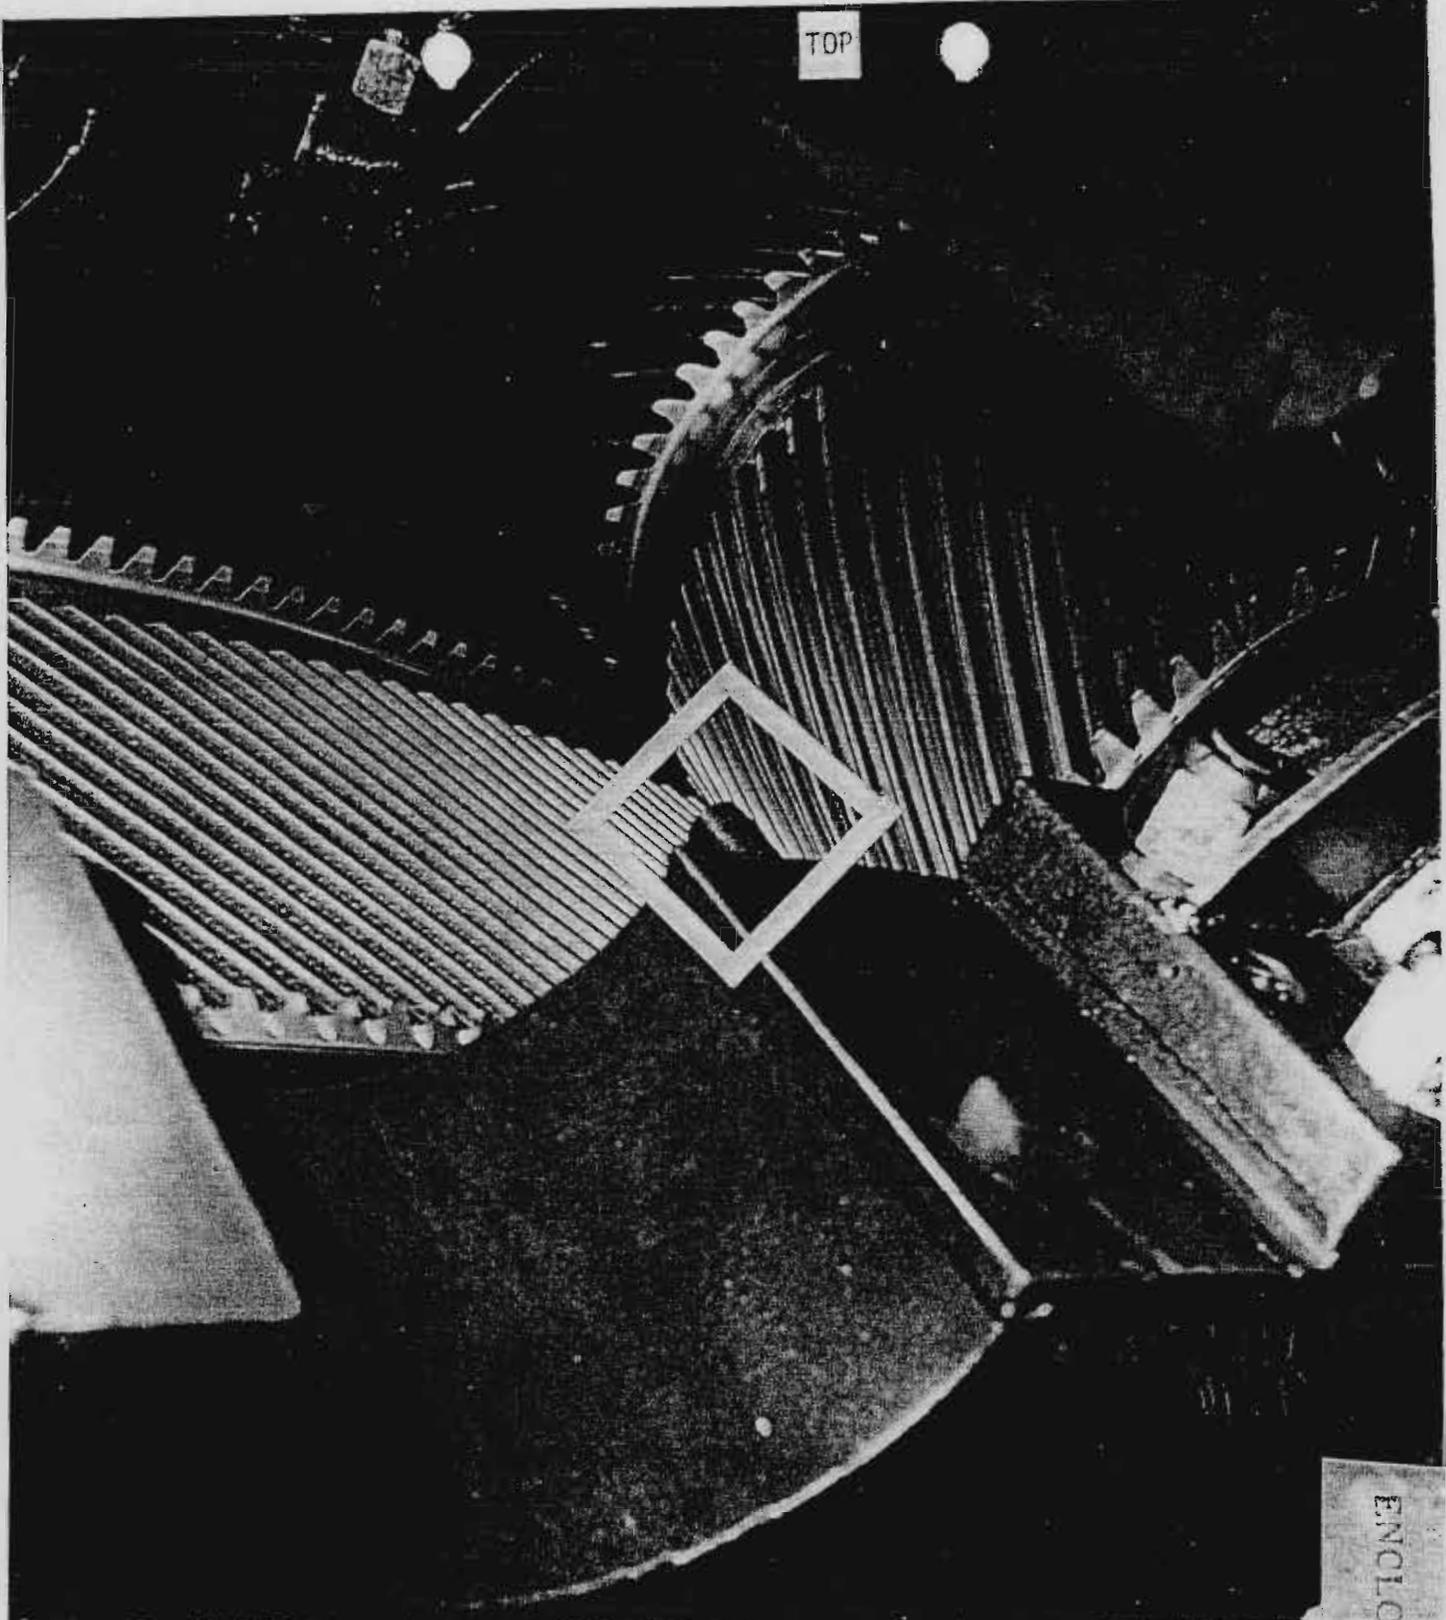
ENCLOSURE 84

Looking from port. at mating surface of lower pinion and Bull gear, object shown is one (1) threaded bolt approx 12" by 1 1/2".

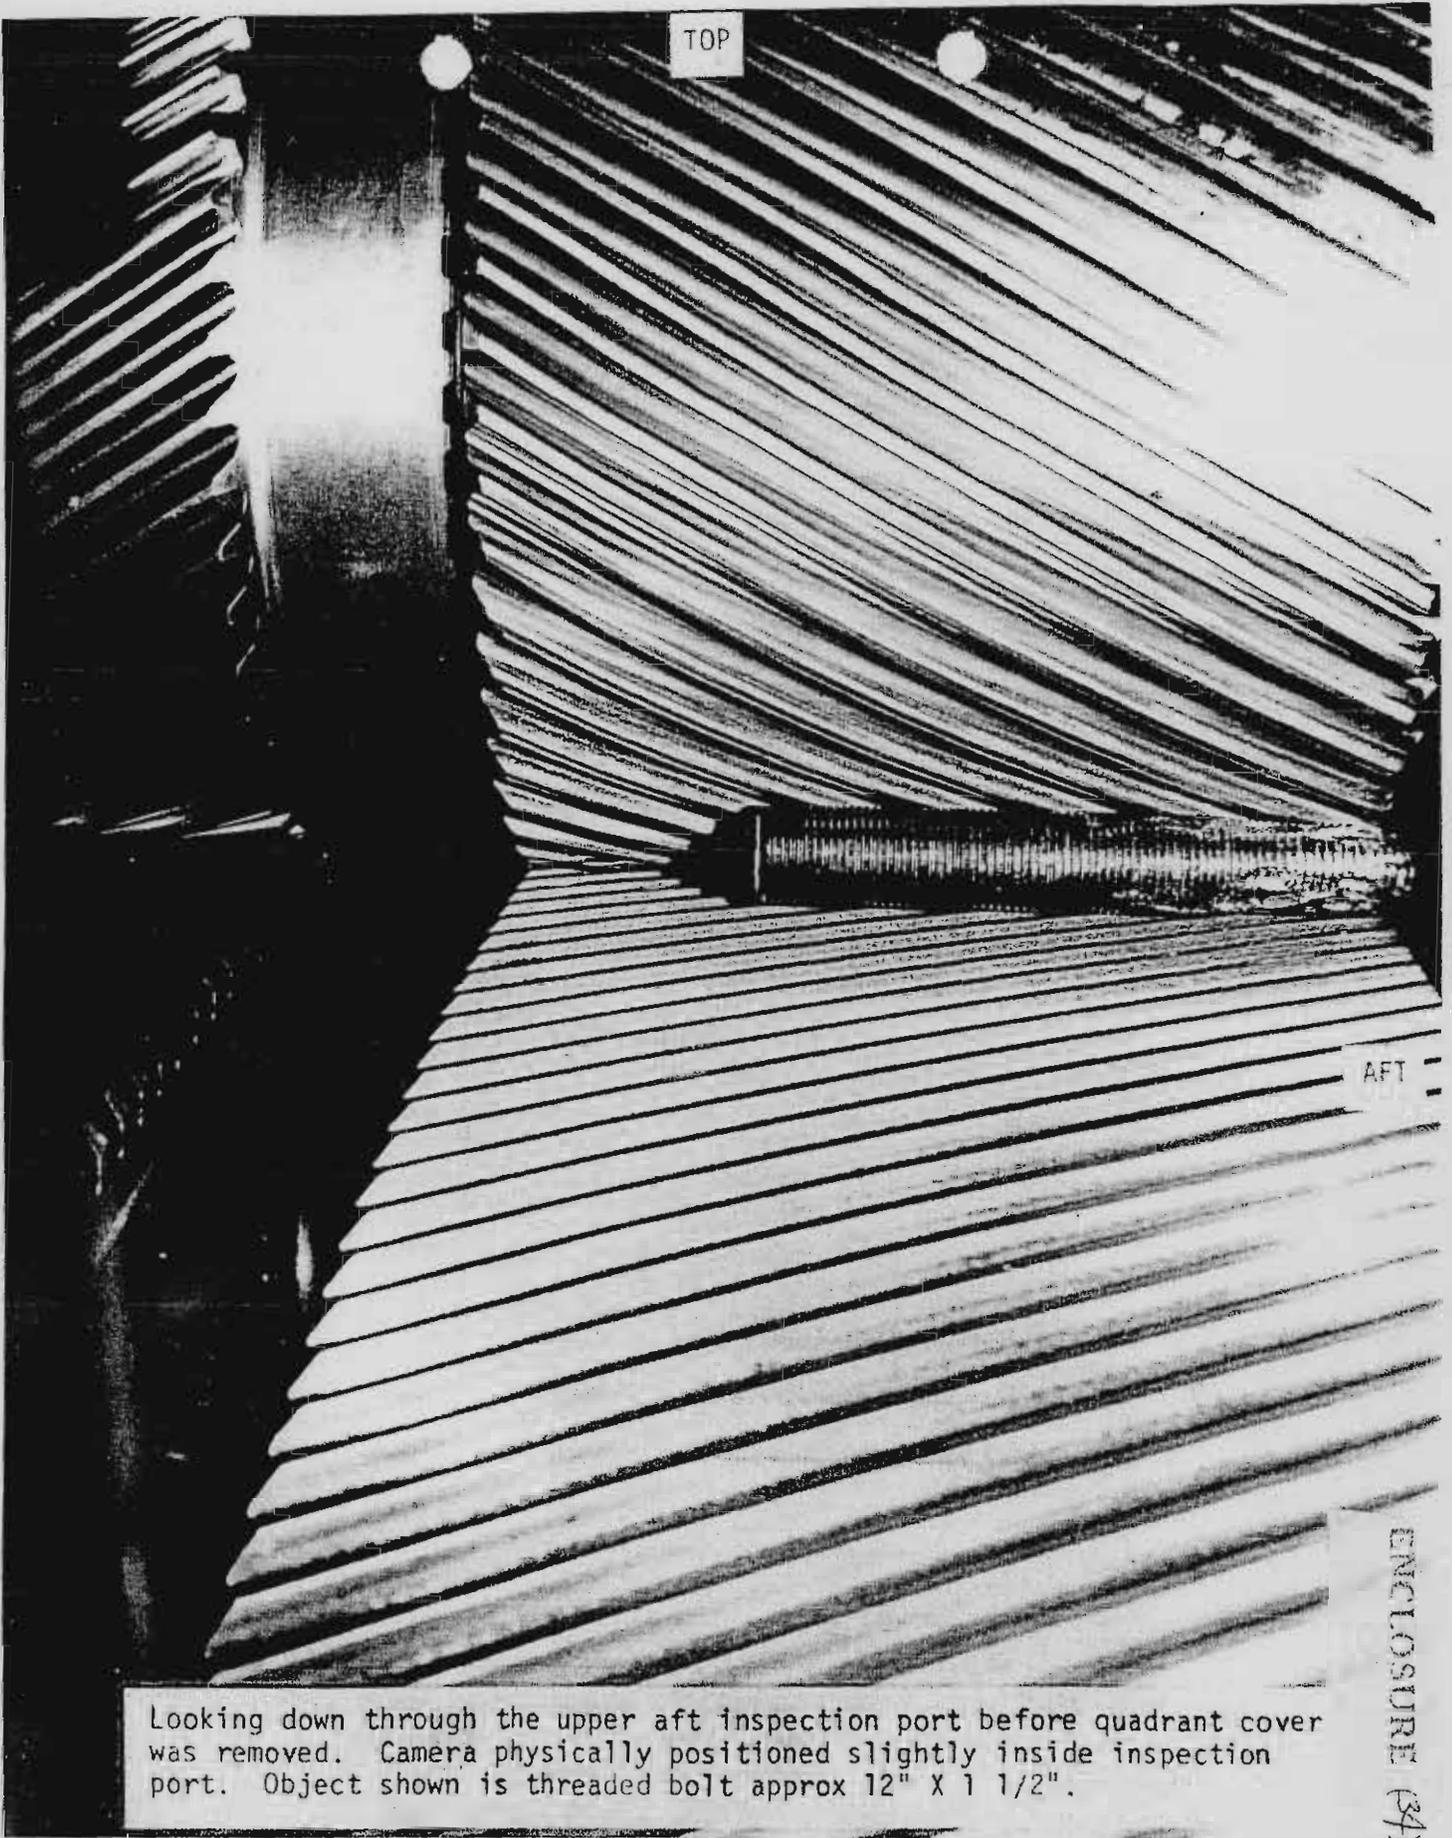
ENCLOSURE (34)

Looking down through the upper aft inspection port before quadrant cover was removed. Camera physically positioned slightly inside inspection port. Object shown is threaded bolt approx 12" X 1 1/2".

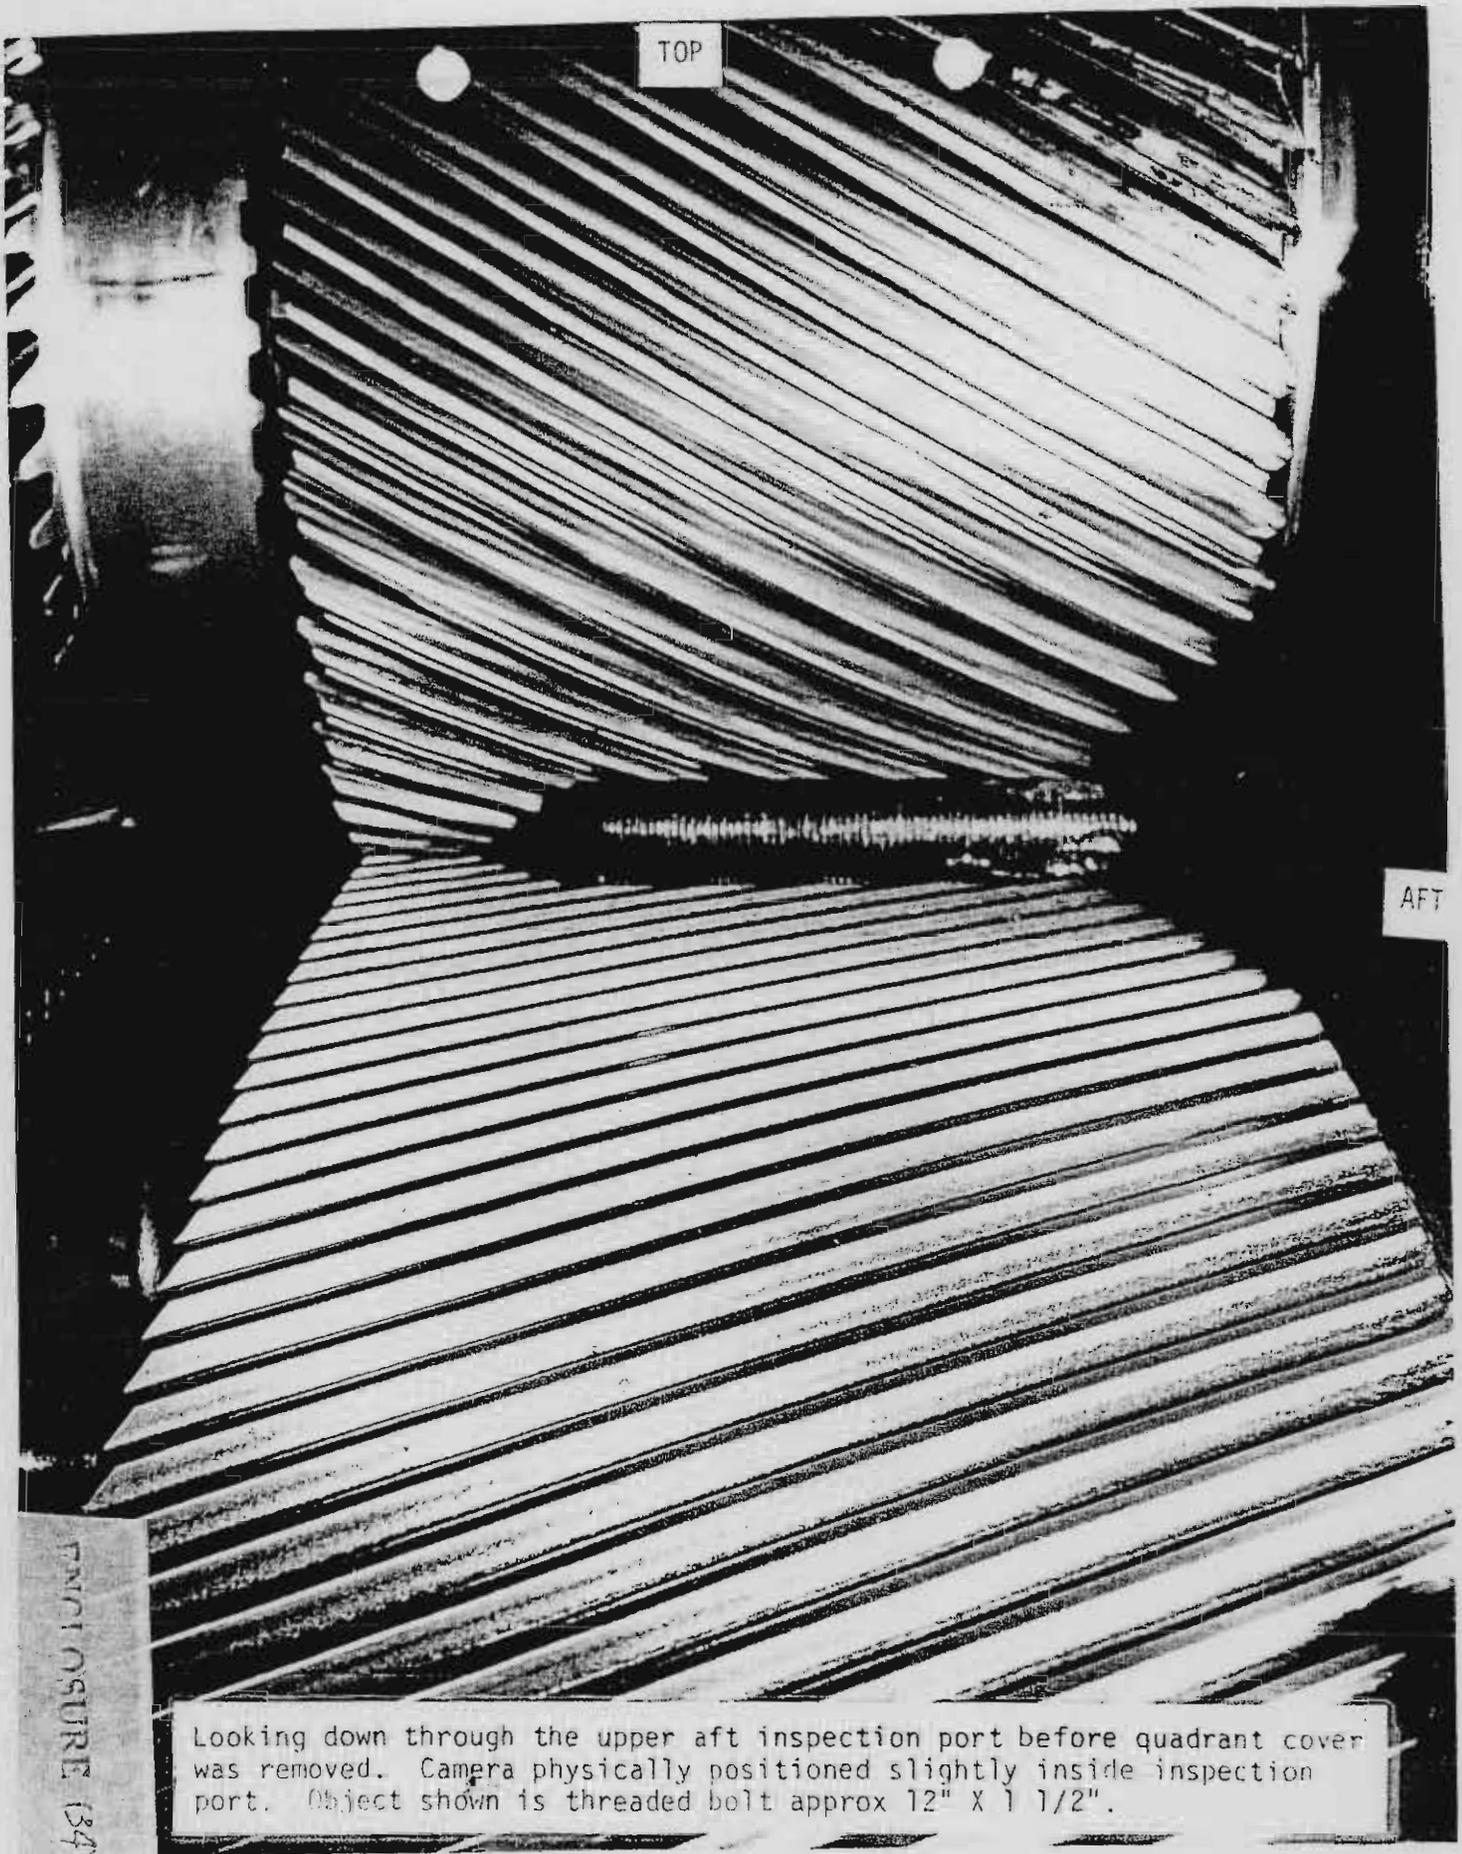
ENCLOSURE (34)

Looking down through the upper aft inspection port before quadrant cover was removed. Camera physically positioned slightly inside inspection port. Object shown is threaded bolt approx 12" X 1 1/2".

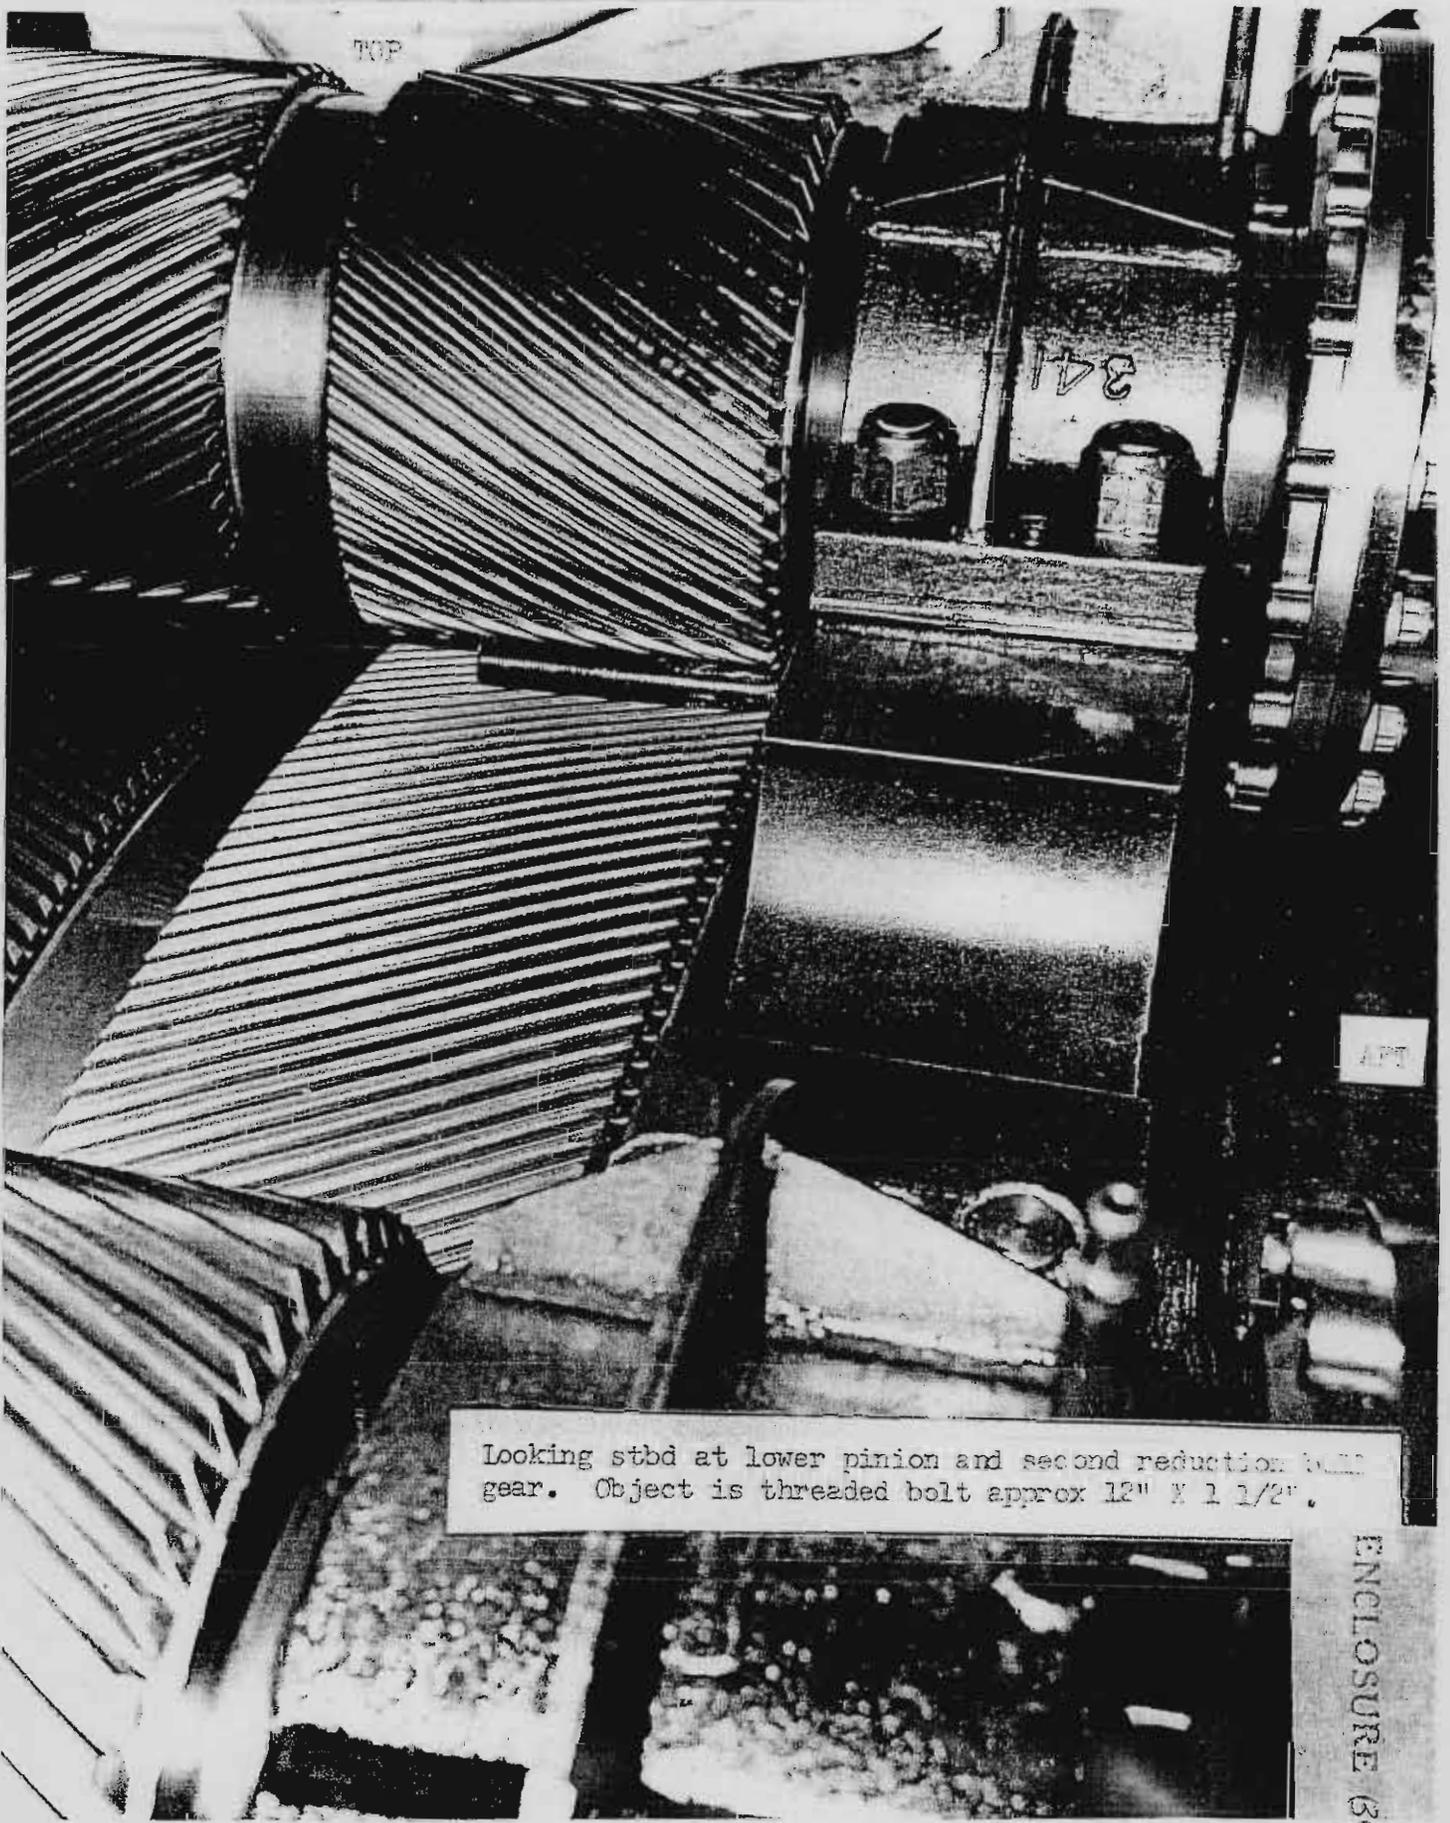
ENCLOSURE (34)

Looking stbd at lower pinion and second reduction ball gear. Object is threaded bolt approx 12" X 1 1/2".

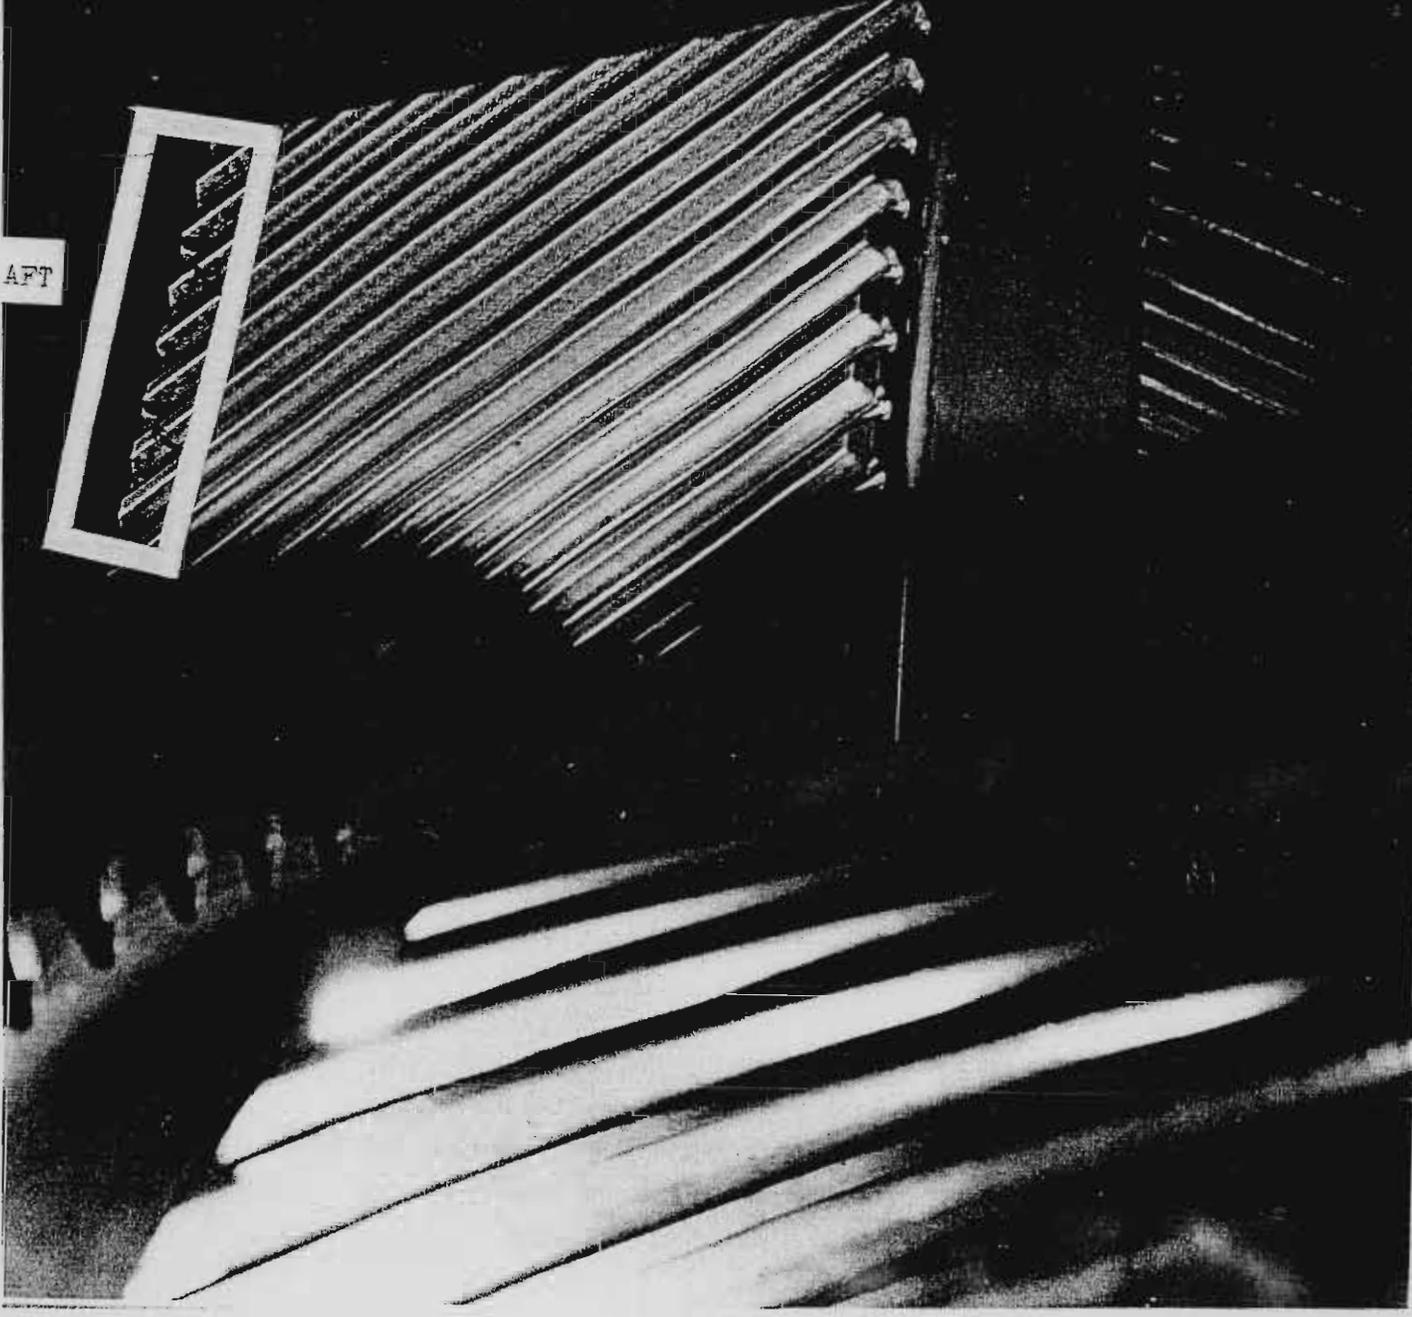
Port side looking aft at upper pinion and second reduction bull gear. Shows damage every fourth tooth.

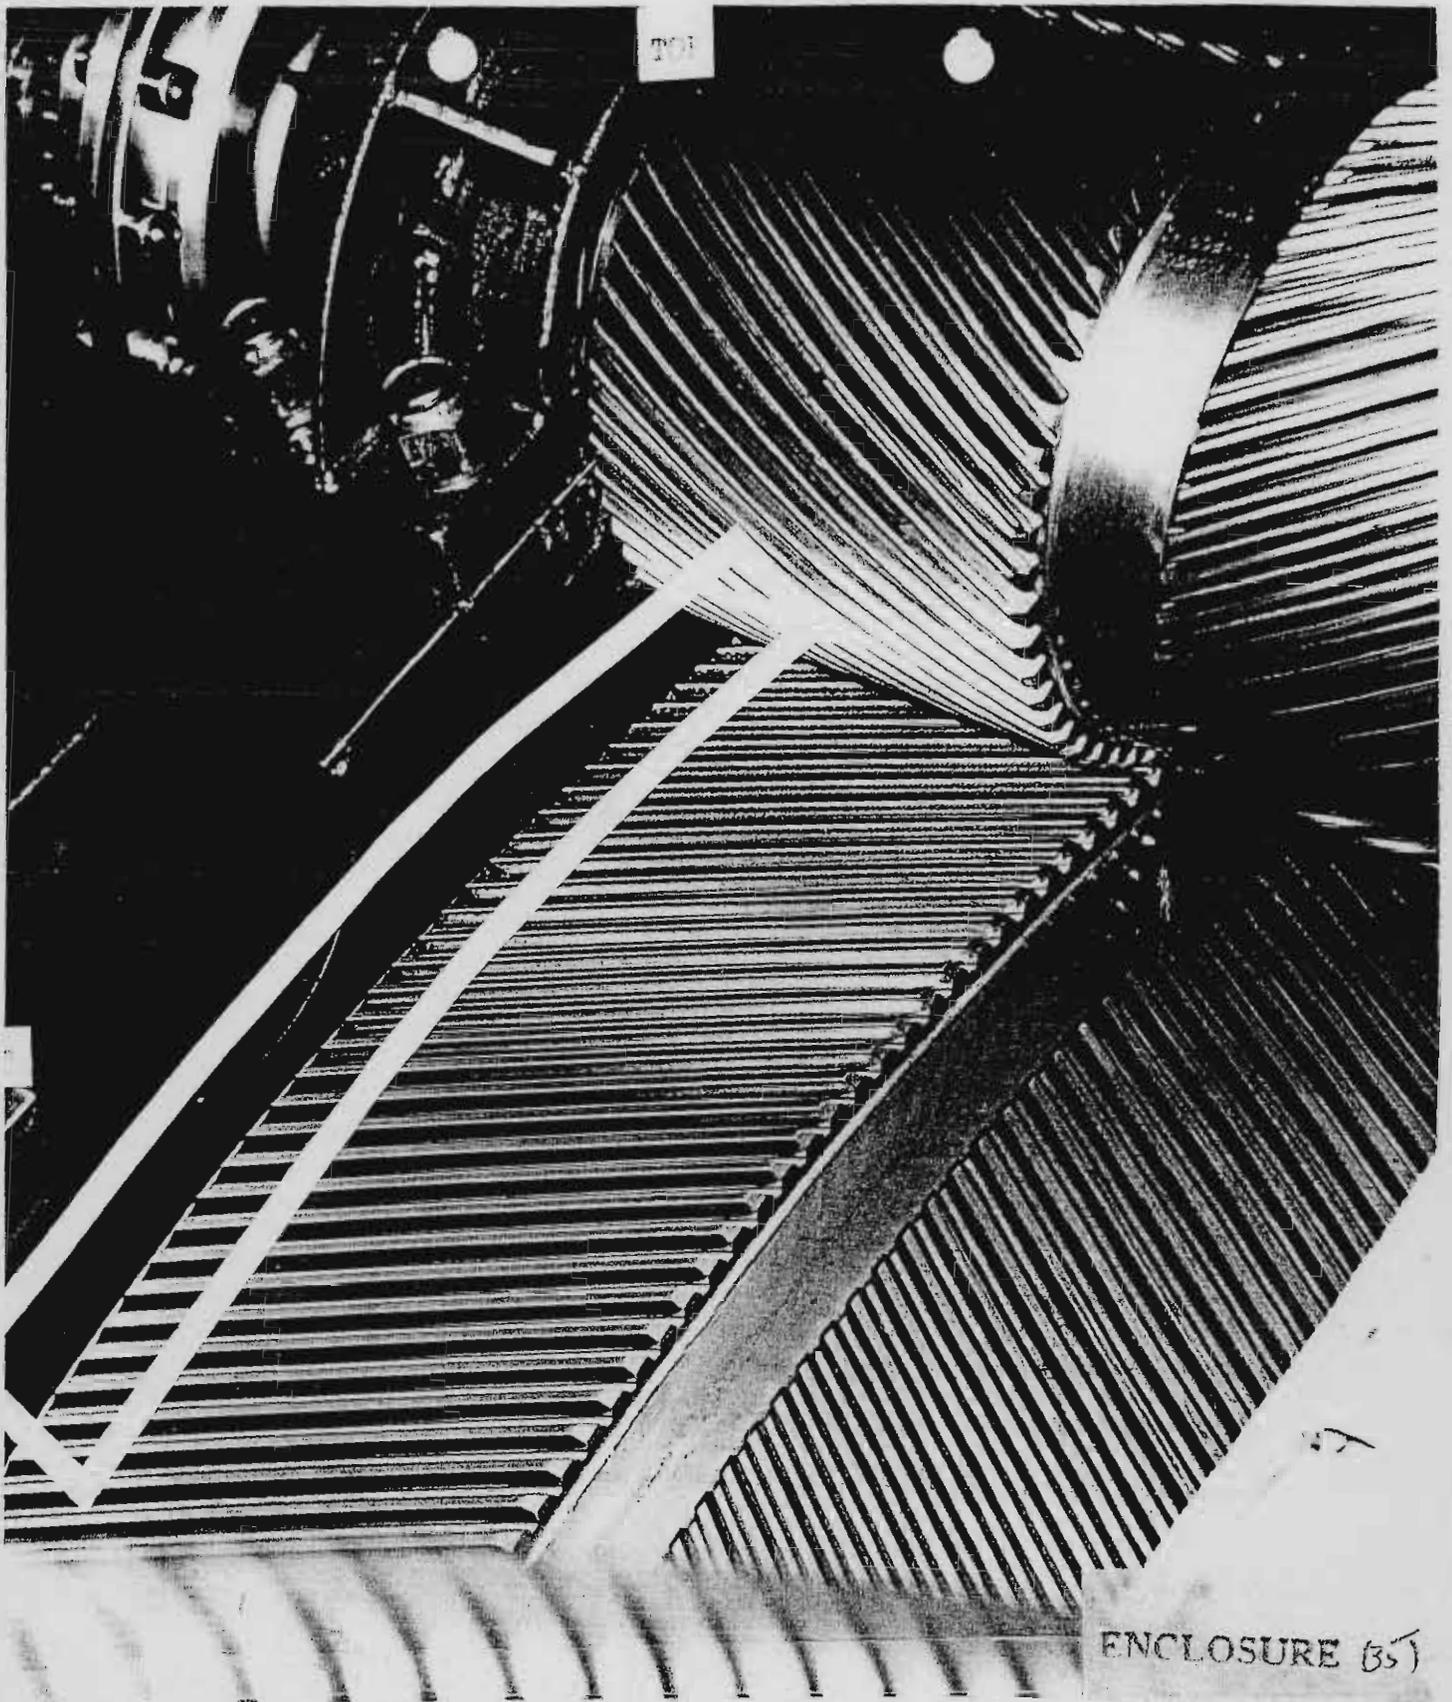
Looking down aft from stbd at second reduction bull gear and upper pinion. Indicates damage on aft trailing edge of bull gear.

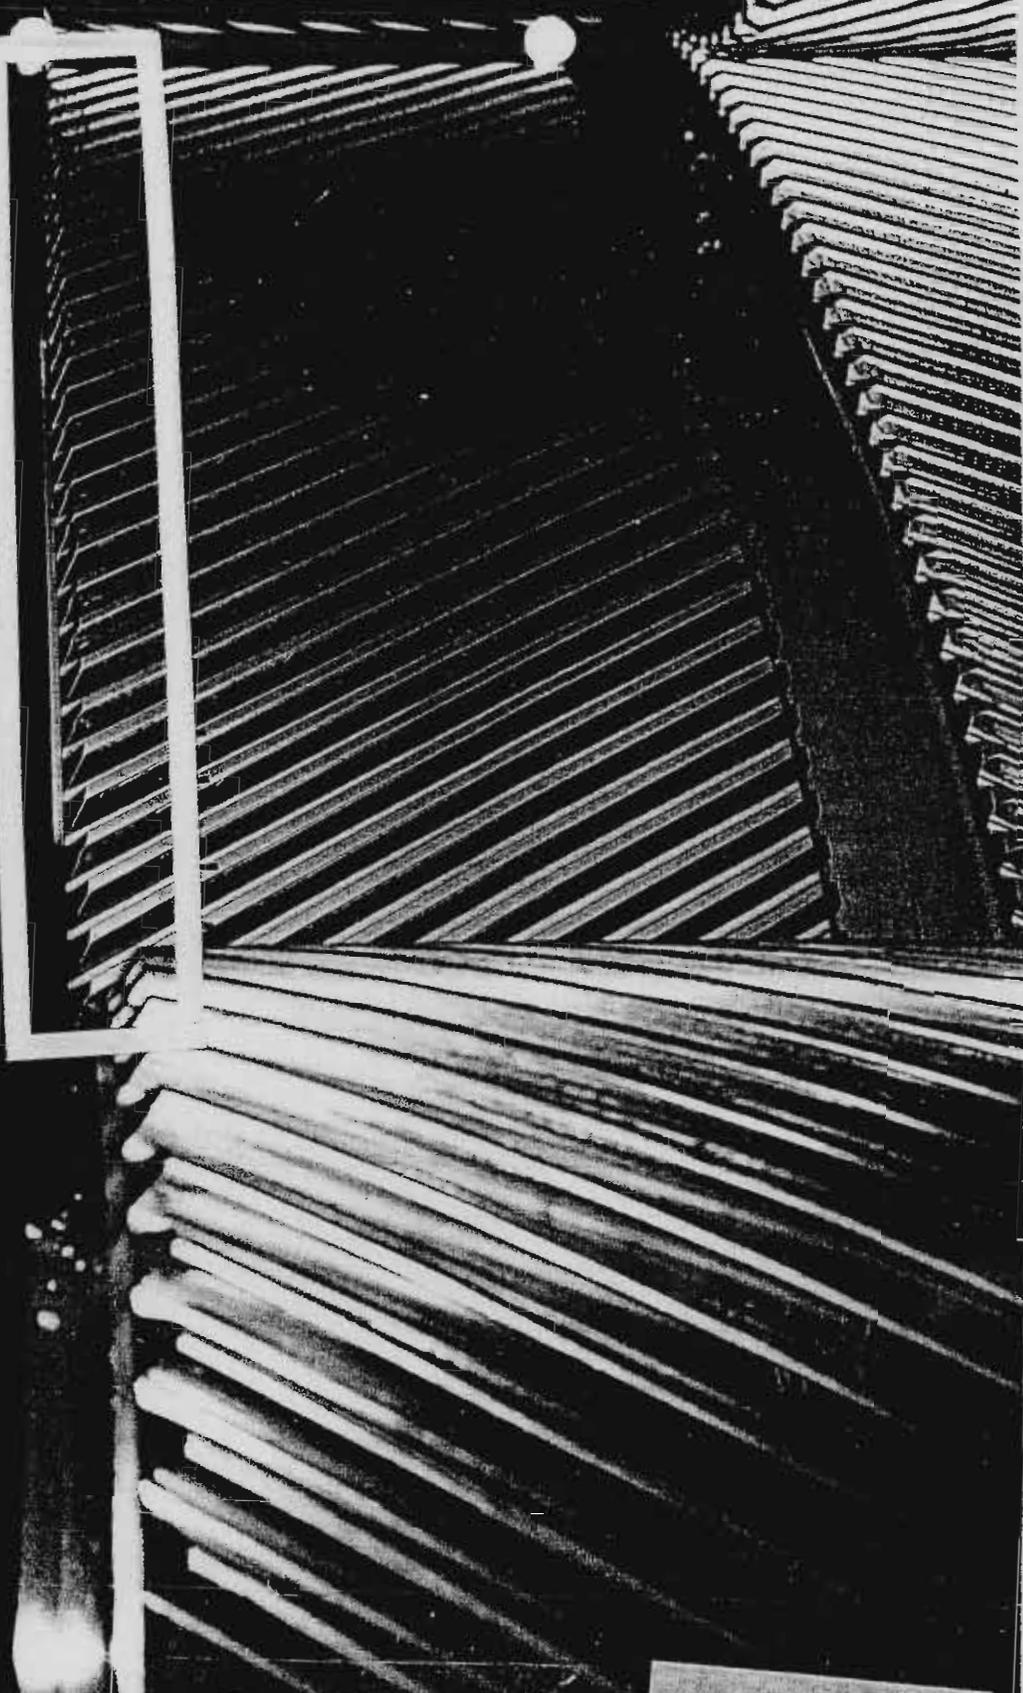
Looking to port at 2nd Reduction Bullgear, upper and lower pinion. Shows damage to trailing edge of Bullgear.
