USS RANGER [CVA-61]
FPO SAN FRANCISCO 96601

Subj: Damage (possible sabotage) in Engineering Spaces of
USS RANGER (CVA 61); supplemental investigation of

- From: Commander Carrier Division THREE
 To: Commander Naval Air Force, U.S. Pacific Fleet
- Subj: Damage (possible sabotage) in Engineering Spaces of USS RANGER (CVA 61); supplemental investigation of
- Ref: (a) COMCARDIV THREE ltr ser 023 of 18 Jul 1972
 (b) NAVSHIPS Technical Manual
 (c) NAVINSERVO Report Control #07-08-72N12-AL77-6 UNA of 2 Aug 1972 (NOTAL)
- Encl: (1) Summary of supplemental unsworn statement of LCDR [redacted], USN
 (2) Summary of supplemental unsworn statement of CDR [redacted], USN
 (3) Summary of supplemental unsworn statement of CAPT [redacted], USN
 (4) Charge Sheet in case of [redacted], dated 2 Aug 1972, with Additional Charge Sheet dated 23 Aug 1972
 (5) Summary of supplemental unsworn statement of CDR [redacted], USN
 (6) USS RANGER INST 5500.2A of 11 Aug 1972
 (7) NISO Report ser 827 of 7 Aug 1972

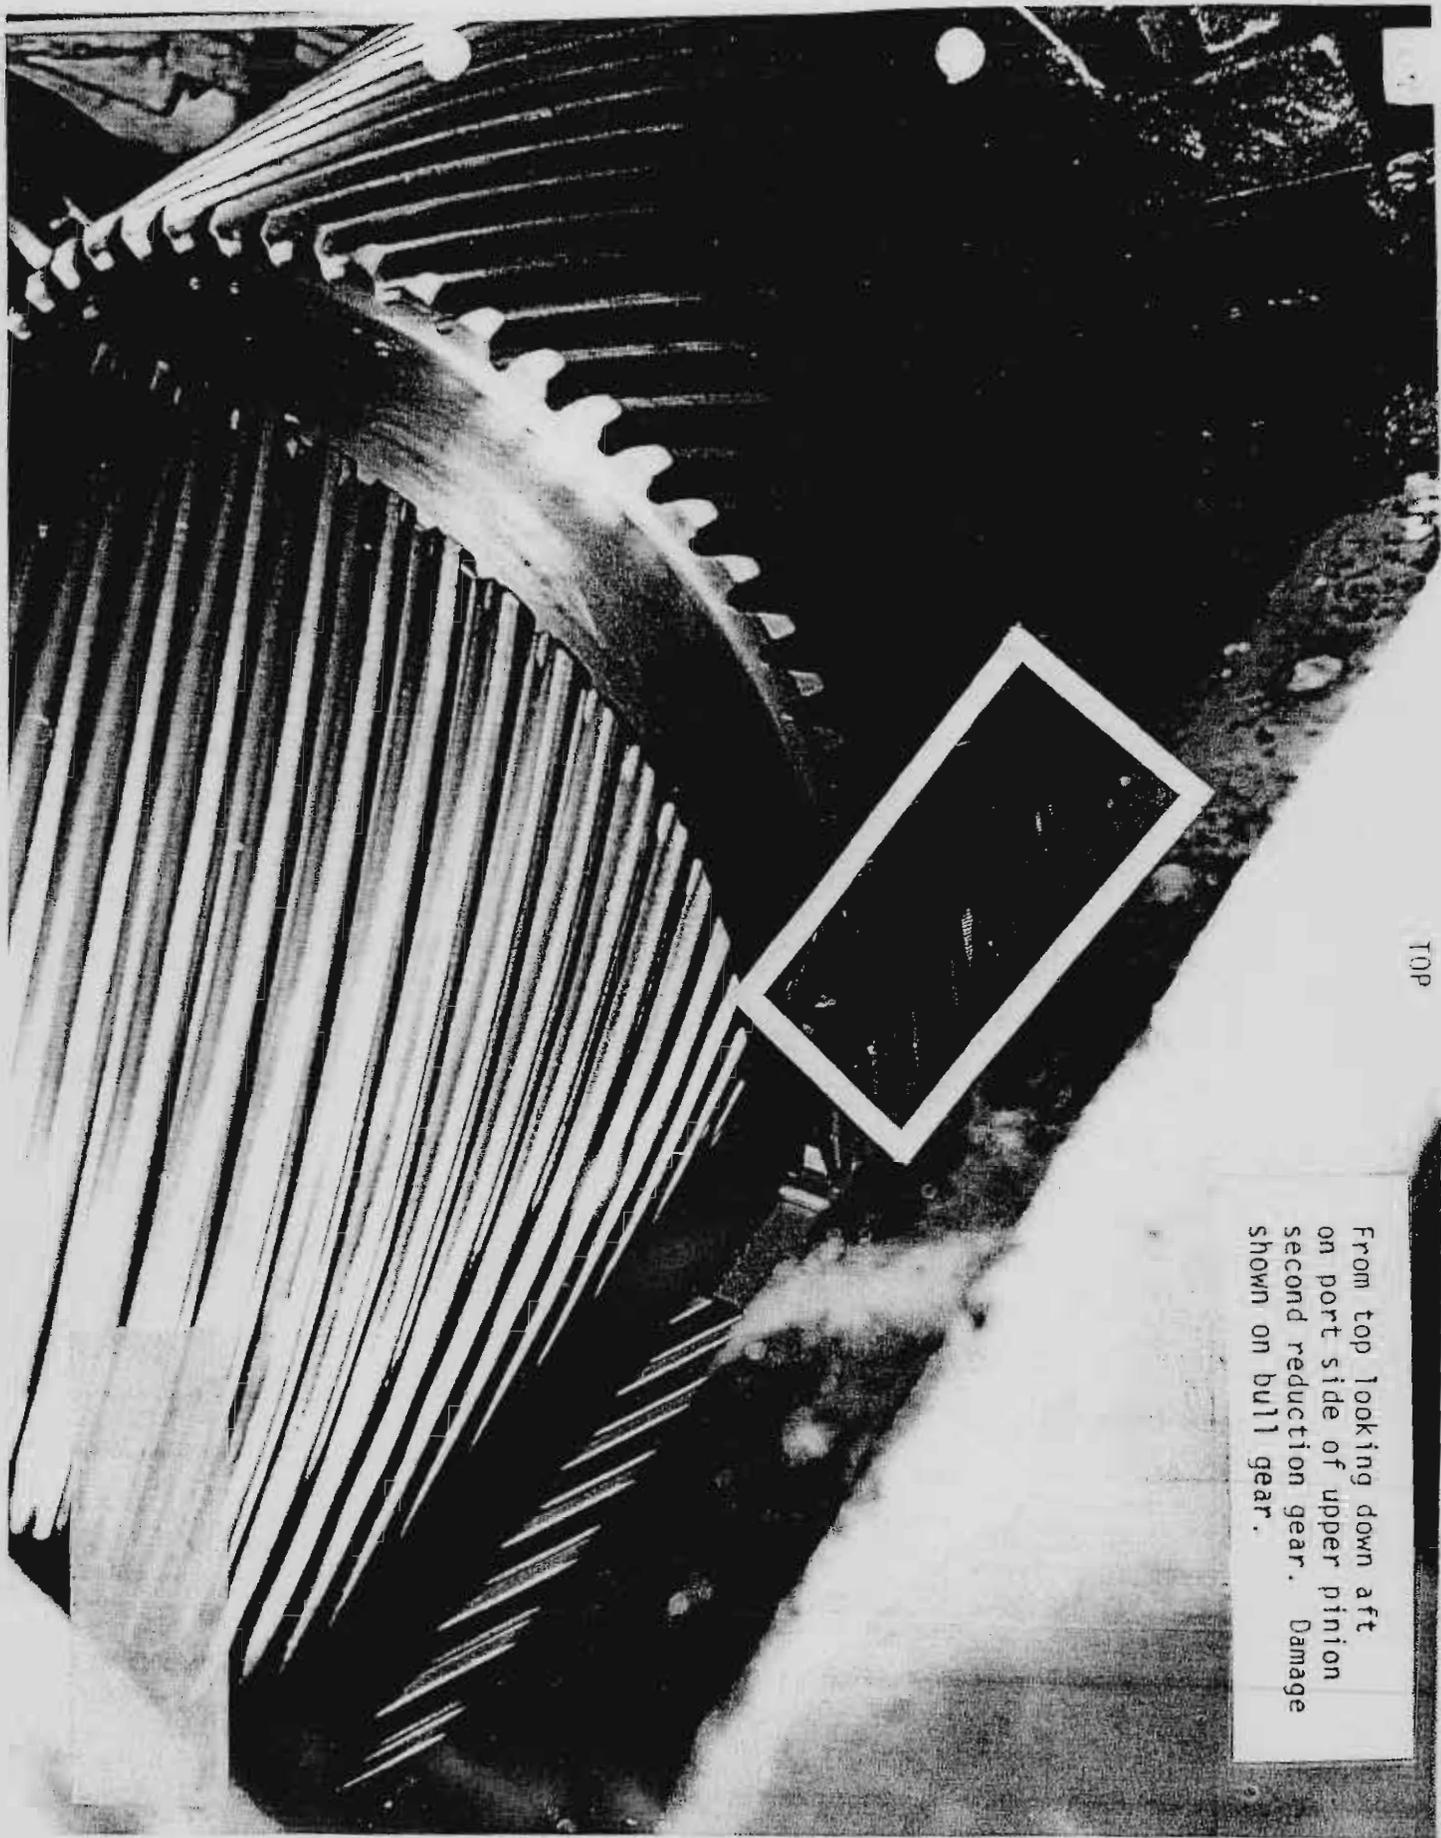
From top looking down aft
on port side of upper pinion
second reduction gear. Damage
shown on bull gear.

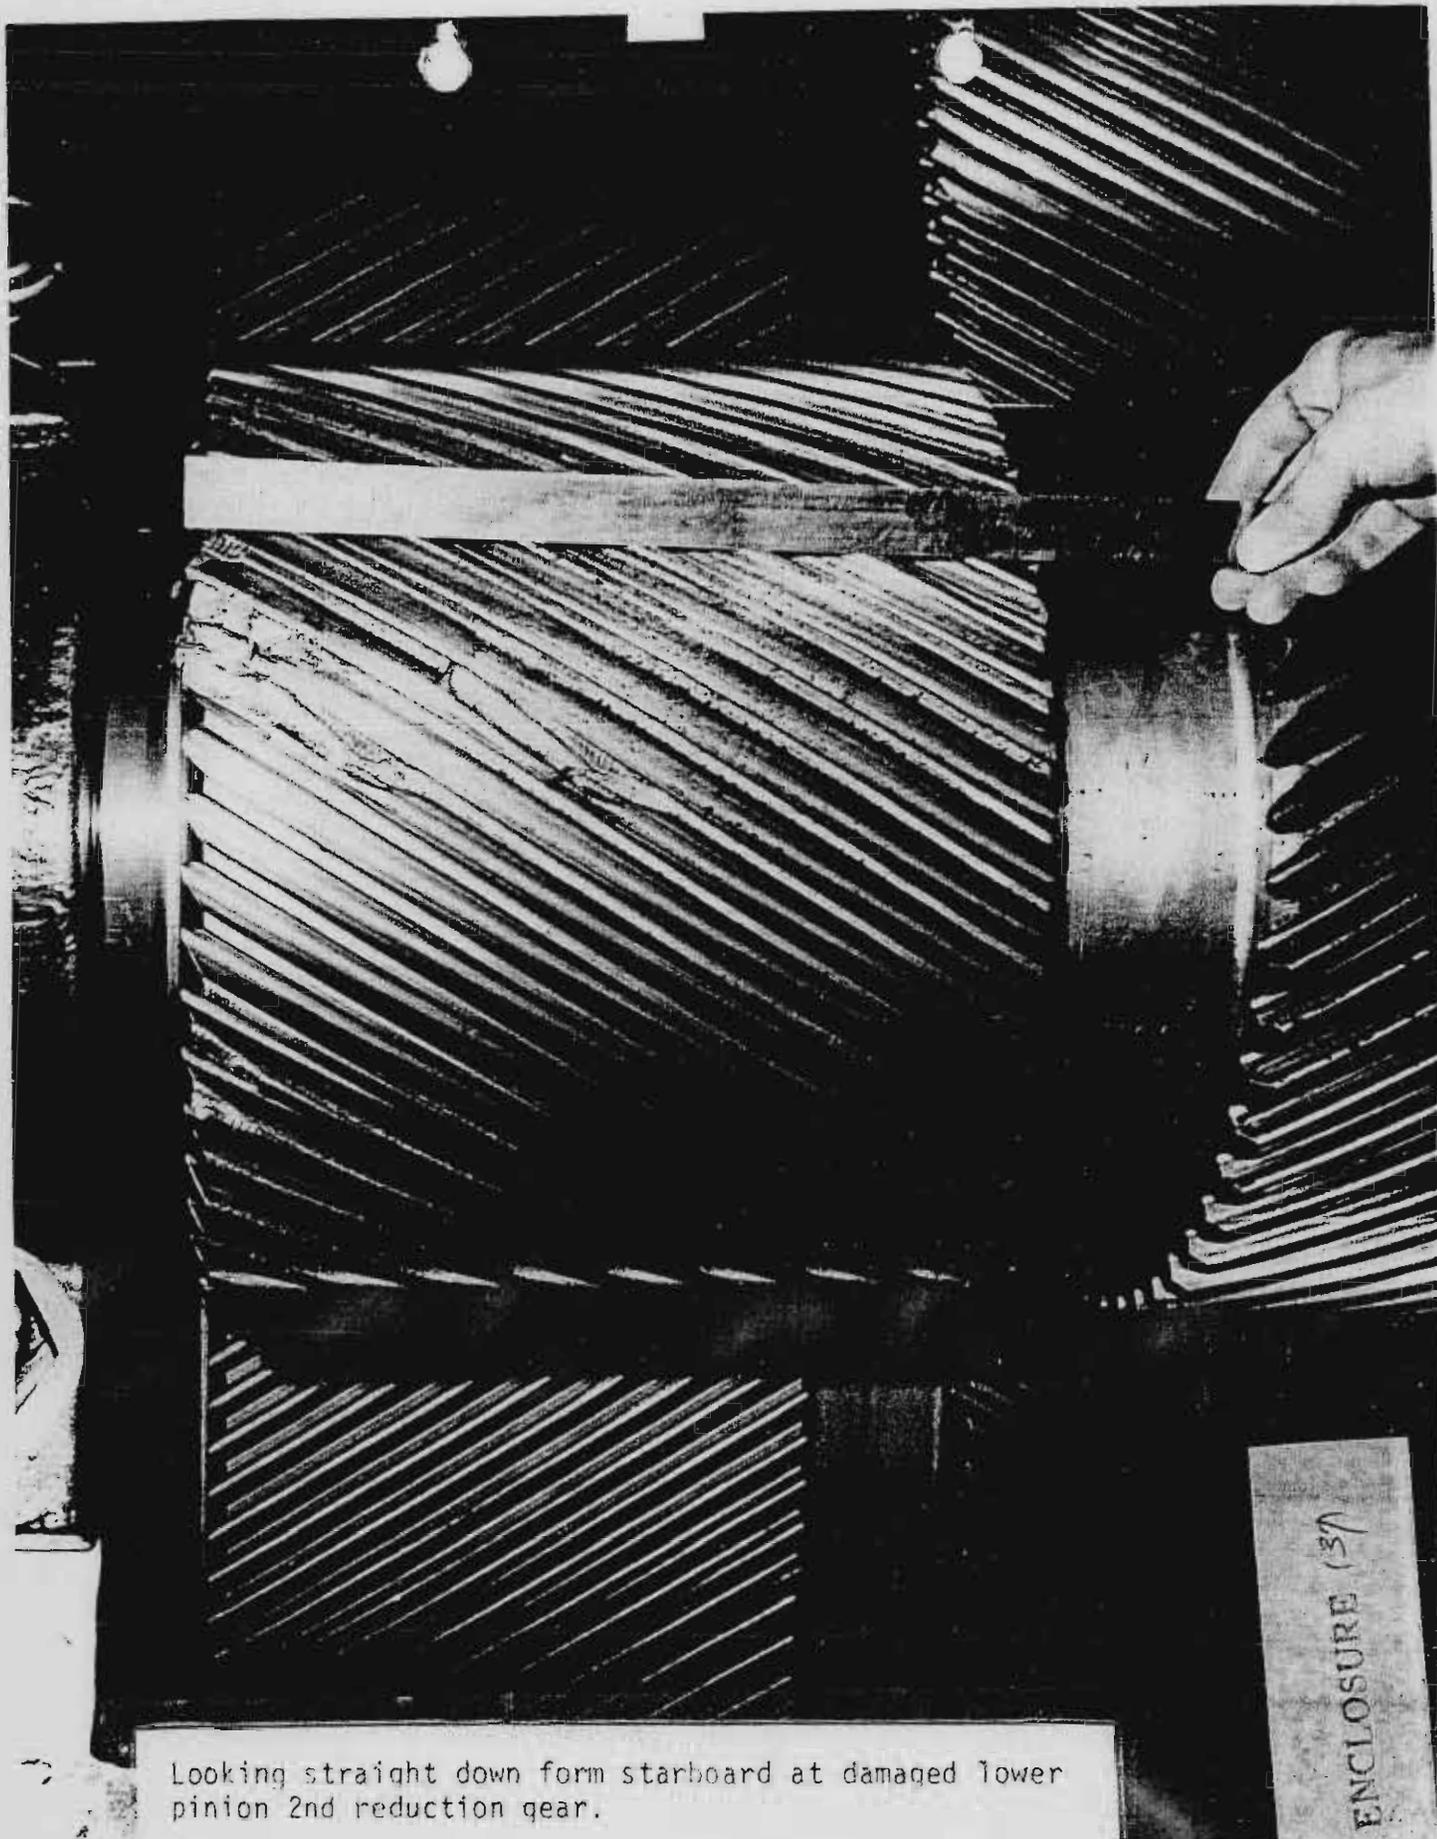
Looking straight down from starboard at damaged lower pinion 2nd reduction gear.

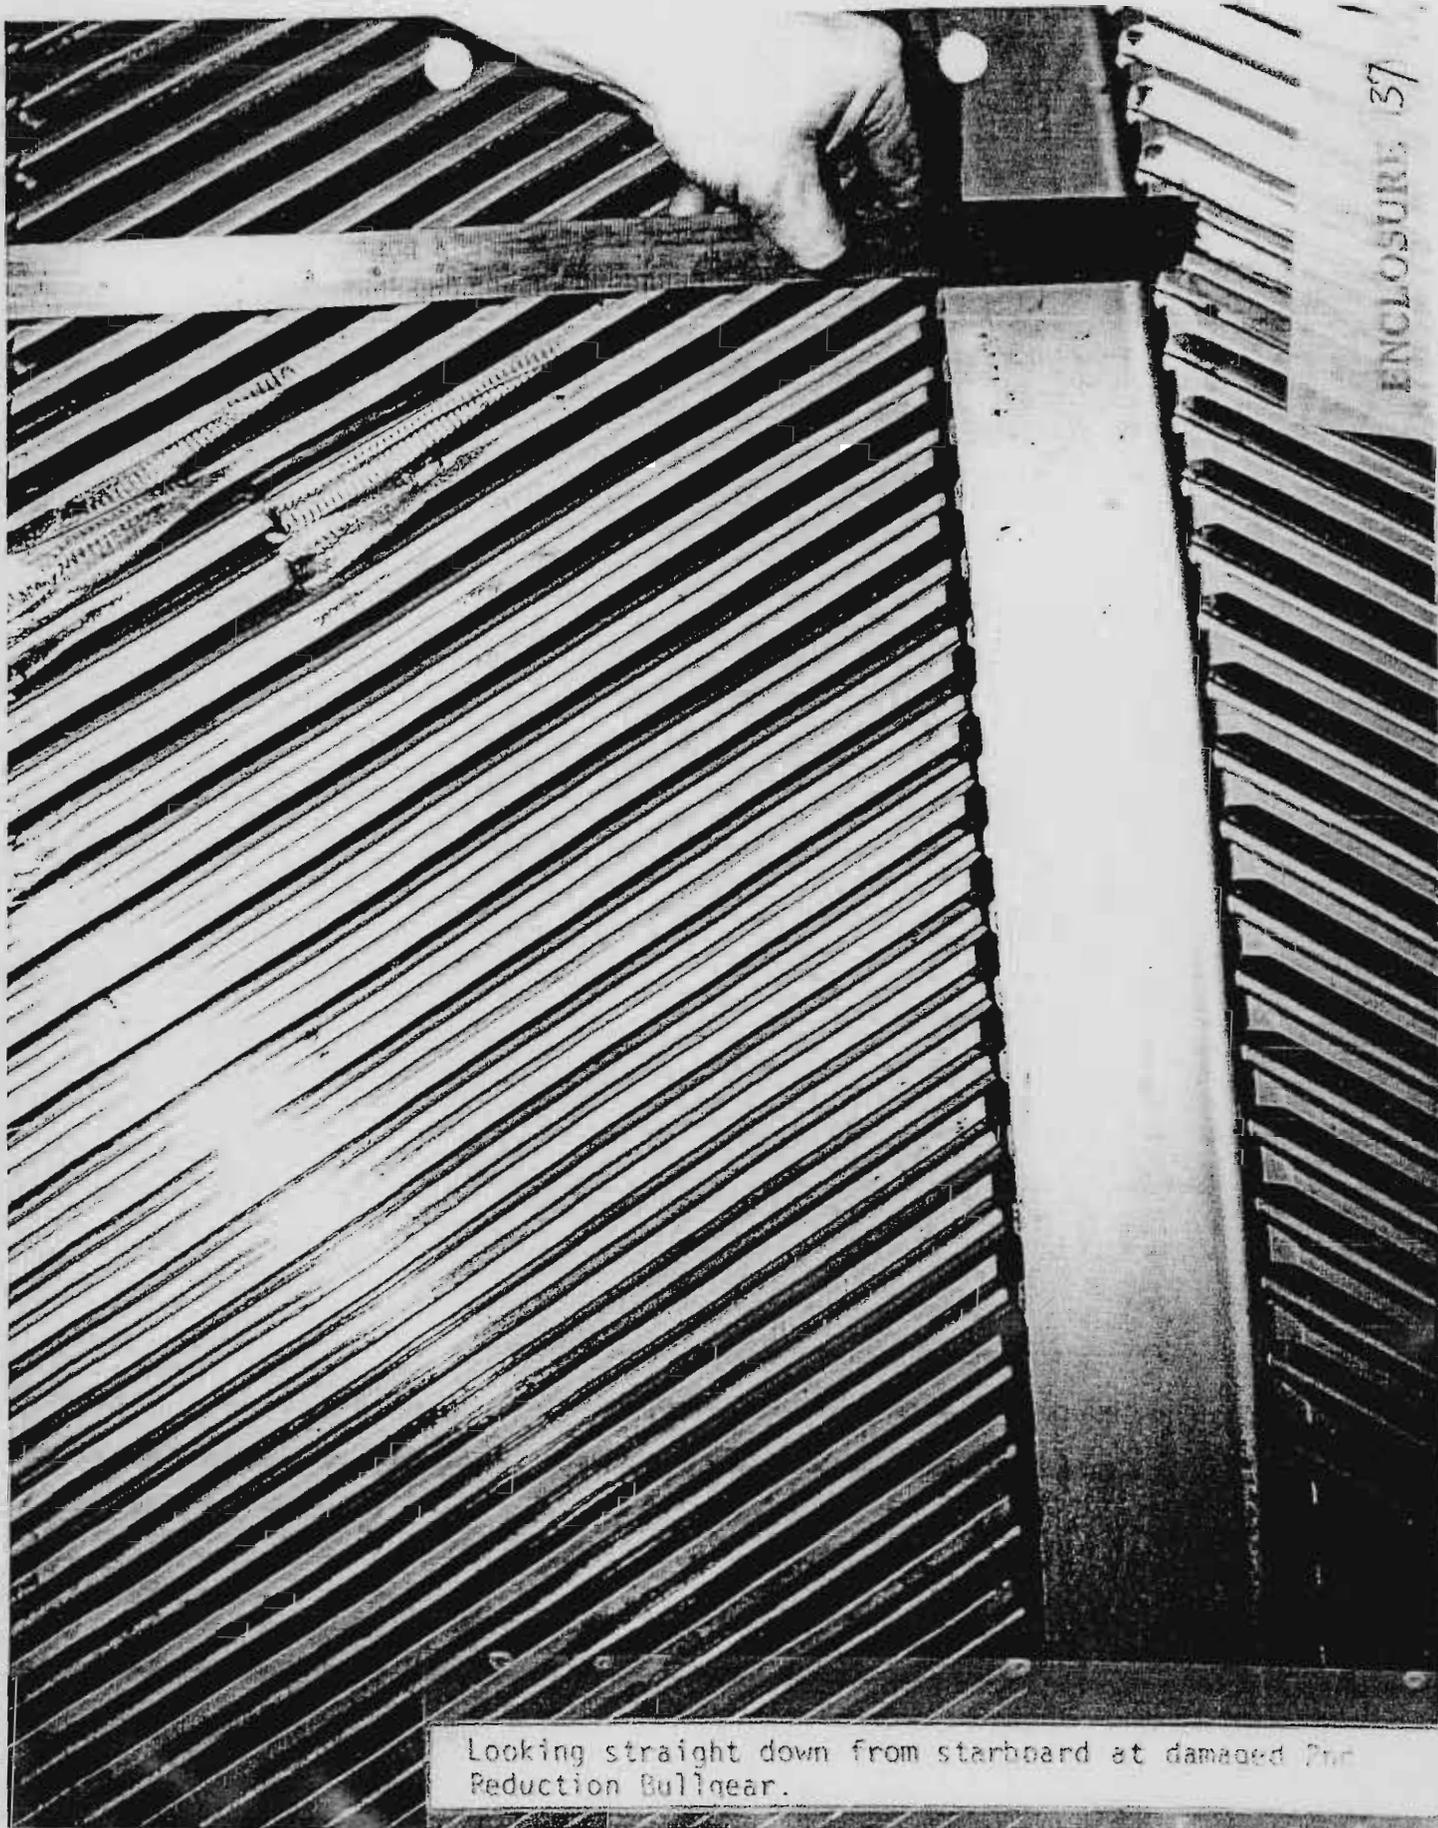
ENCLOSURE 37

Looking straight down from starboard at damaged Pin Reduction Bullgear.
