DEPARTMENT OF THE NAVY  
OFFICE OF THE JUDGE ADVOCATE GENERAL  
200 STOVALL STREET  
ALEXANDRIA, VA 22332-2400

THIRD ENDORSEMENT on RADM , USN, B(4)  
investigative report of 12 Mar 86

Subj: INVESTIGATION TO INQUIRE INTO THE CIRCUMSTANCES CONNECTED  
WITH THE COLLISION BETWEEN USS JASON (AR 8) AND USS WILLAMETTE  
(AO 180), WHICH OCCURRED AT ABOUT 2115W ON 10 FEB 86,  
APPROXIMATELY 60 NM SOUTHWEST OF OAHU, HI, AND THE DEATH OF  
HTC SUSANO R. VALDEZ, USN, B(4)

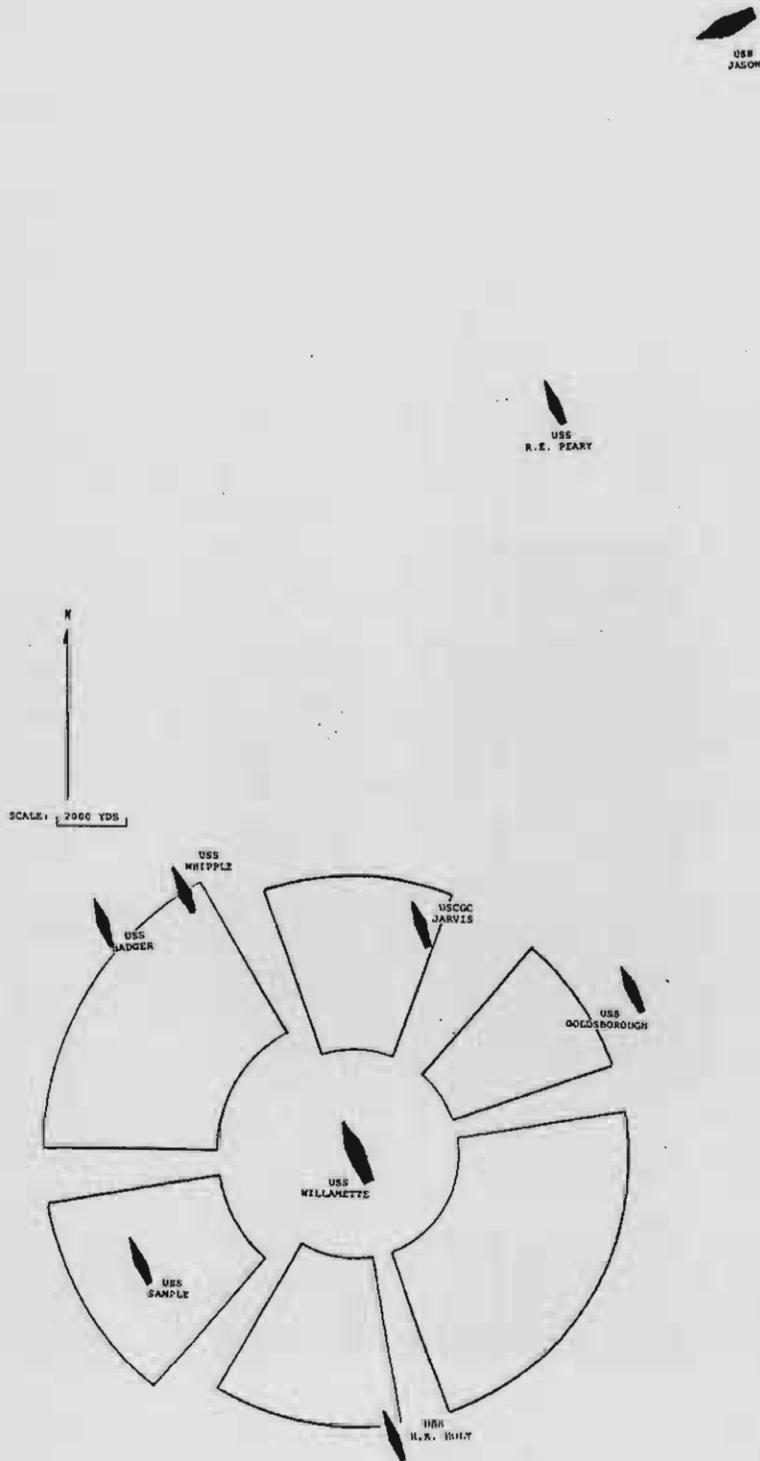
40. (U) At 2010W, the disposition of the formation was as indicated below:

41. (U) At 2010W, WILLAMETTE was located approximately 198°T, 34,700 yards from JASON.

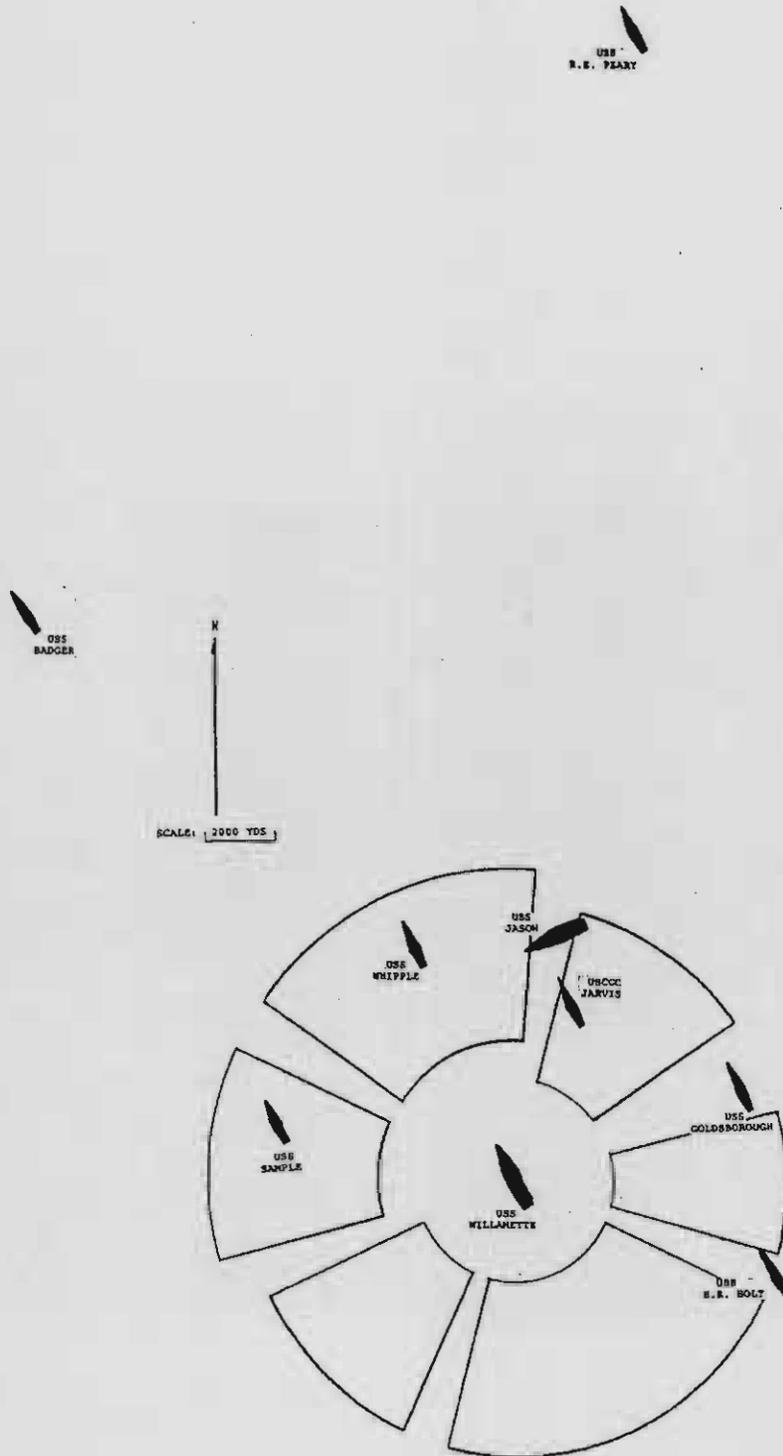
62. (U) At 2100W, the disposition of the formation was as follows:

63. (U) At 2101W, JARVIS held JASON bearing 349°T at a range of 1500 yards. JARVIS then reduced speed from 15 knots to 10 knots.
