Subj: Investigation into the circumstances surrounding the fire which
occurred on or about 2050, 10 January 1970 on the starboard bow,
flight deck of USS SHANGRI LA (CVS 38)

FIRST ENDORSEMENT on Investigative Report of Commander
U. S. Navy, letter of 10 March 1970

Subj: Investigation into the circumstances surrounding the fire which occurred on or about 2050, 10 January 1970, on the starboard bow flight deck of USS SHANGRI-LA (CVS-38)

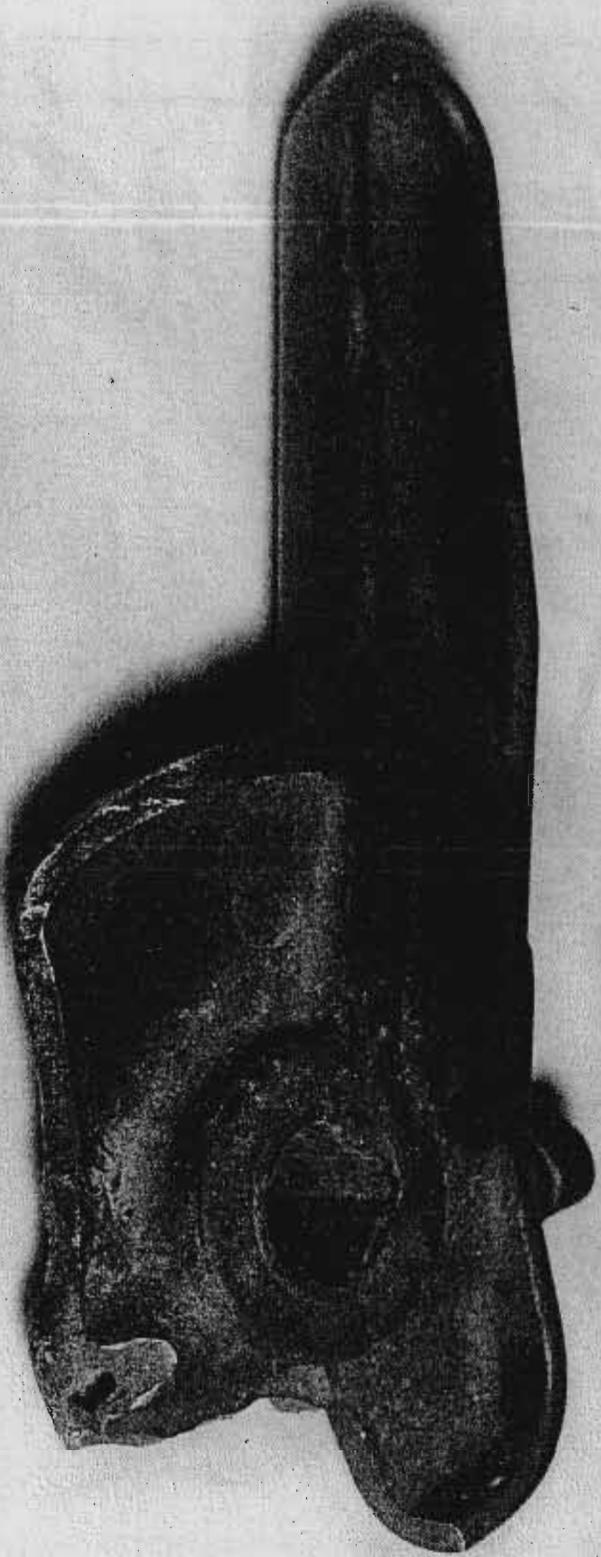
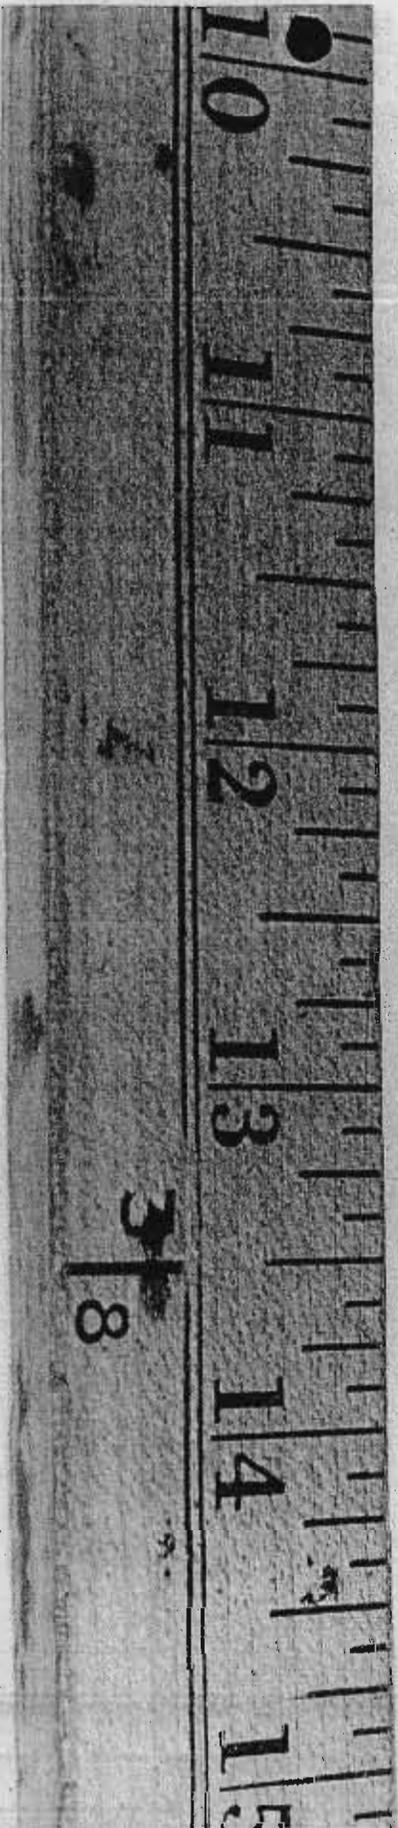
ENCLOSURE (22)

13. The fueling nozzle used in this case, FSN 4930-313-8986 and adapter cap assembly (PN 7-255-1), fuel valve ON/OFF handle (Enclosure 22) had the lobe broken off (Enclosure 12). The lobe is a safety device which prevents valve accuation until the nozzle is fully locked. Additionally, it prevents removal of the nozzle until the ON/OFF handle is in the fully closed position. An inspection after the accident of all installed nozzles of this type revealed none with a broken lobe.

d. The fuel control valve handle, P/N 23574, had the "safety" portion of the lobe broken off. (See enclosure (1)). Laboratory analysis of the handle indicated: "It was extremely difficult to predict the actual time of fracture. No apparent heat damage to the part from or during the accident was noted. The fracture of the handle and the physical damage and marking appear to be primarily of an old nature, and present for some time. No apparent fatigue failure or metallurgical defects were found in the fracture area. The apparent evidence indicates the fracture of the handle occurred prior to the attempted refueling of the aircraft."

a. All activities using the J. C. Carter Company pressure fueling nozzle, P/N 6902, inspect the fuel control handle immediately, and prior to each use of the nozzle. Nozzles found with broken "safety" lobes should not be used under any conditions, until the handle is replaced. Additionally, it is recommended that activities inspect the groove of the cage for folded up metal; any nozzles found with folded metal should be replaced to preclude loss of and subsequent ingestion of this metal into the aircraft fuel system or engine.
