UNITED STATES MARINE CORPS
MARINE FORCES RESERVE
2000 OPELOUSAS AVE.
NEW ORLEANS LA 70114

Subj: COMMAND INVESTIGATION INTO THE CLASS A AVIATION MISHAP WITHIN
MARINE AERIAL REFUELER TRANSPORT SQUADRON 452 ON 10 JULY 2017

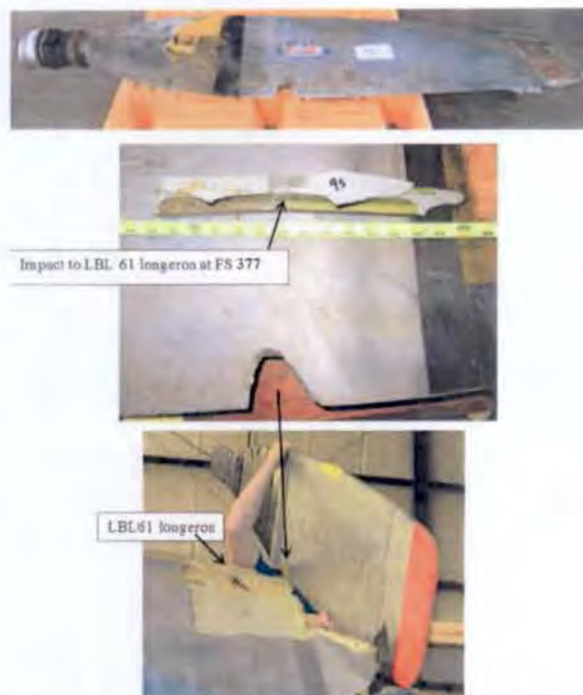
Figure 6: Reconstruction of P2B4 Impacting Port Side Panel

120. While in flight, blade four of propeller two departed the aircraft. [Encls (13), (21), (22)]

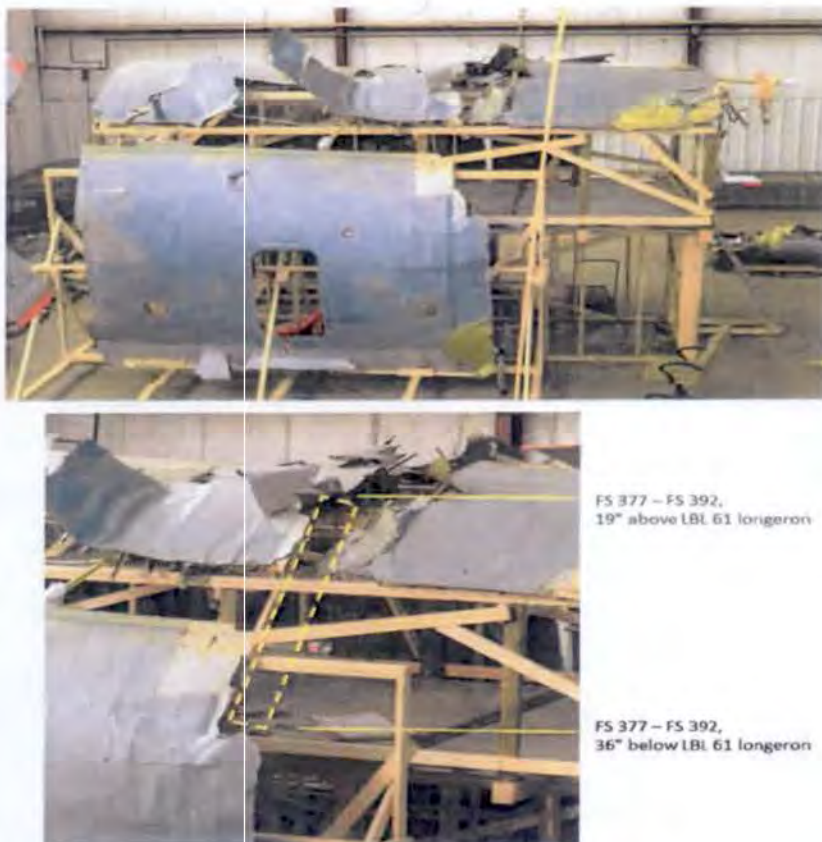
Figure 7: P2B4 Fuselage Damage

121. After departure, P2B4 sliced through the port side of the fuselage at FS 377 slightly aft of the propeller arc plane upon entry in a near vertical orientation. This deteriorated the left side longeron support structures as the tip cut 36 inches below left butt line (LBL) 61 and the root end of the blade impacted 19 inches above LBL 61. P2B4 then passed unobstructed through the MAC interior, and did not exit the airframe but rather impacted the interior starboard side of the cargo compartment where it remained until cargo compartment separation. [Encls (13), (21), (22)]

122. P2B4's intrusion resulted in an overload failure of the LBL 61 longeron on both sides of the impact point at FS 377. [Encl (21)]

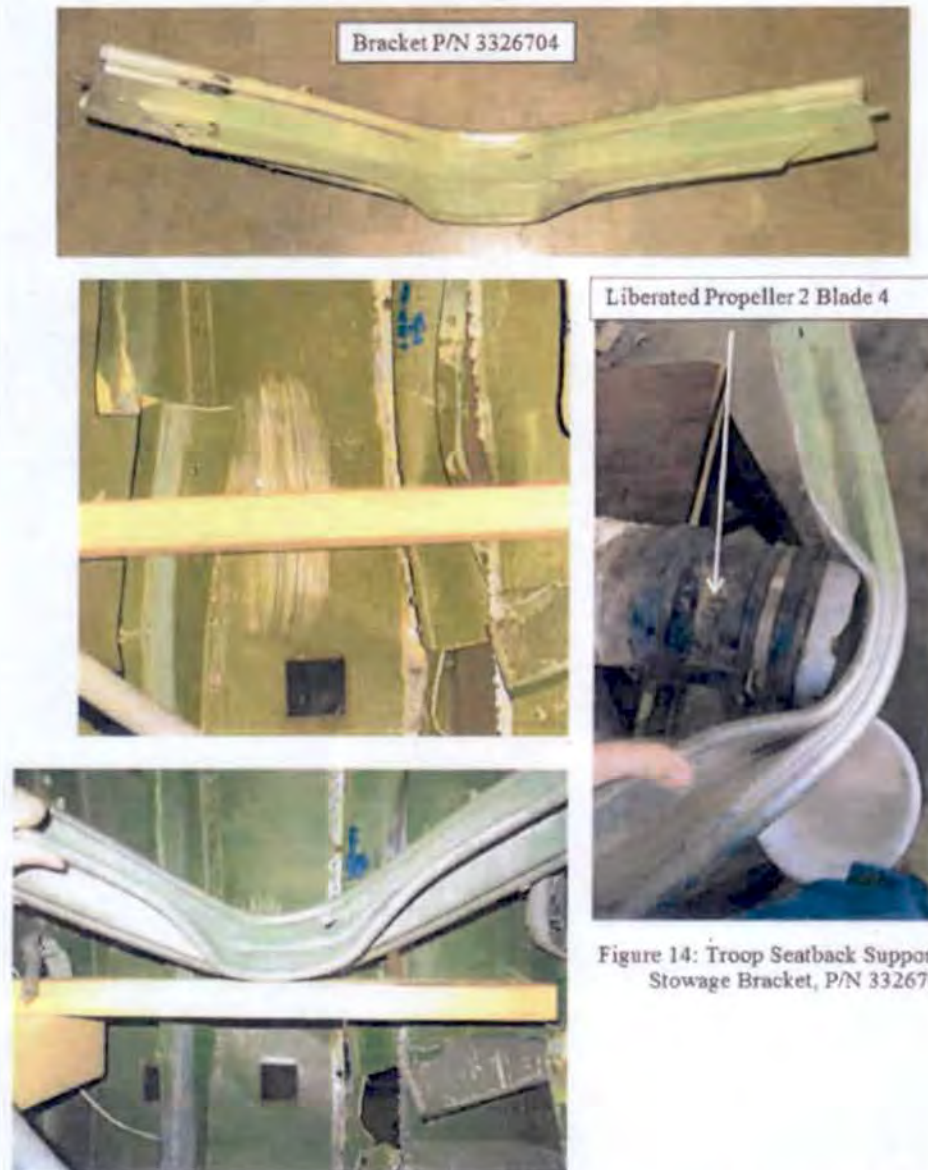
Figure 8: Reconstruction of P2B4 Impact to Stanchion Bracket

123. When P2B4 passed unobstructed through the occupied space of the fuselage and impacted the starboard interior, the butt end of the blade then embedded into the robust stanchion bracket from a troop seatback support beam stowage assembly on the starboard side of the fuselage near waterline (WL) 200 between the ring segments at FS 383.67 and FS 397. [Encl (21)]

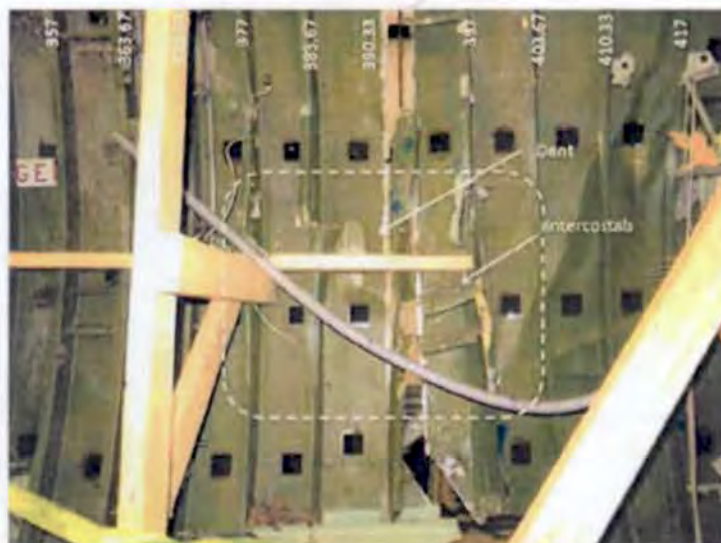
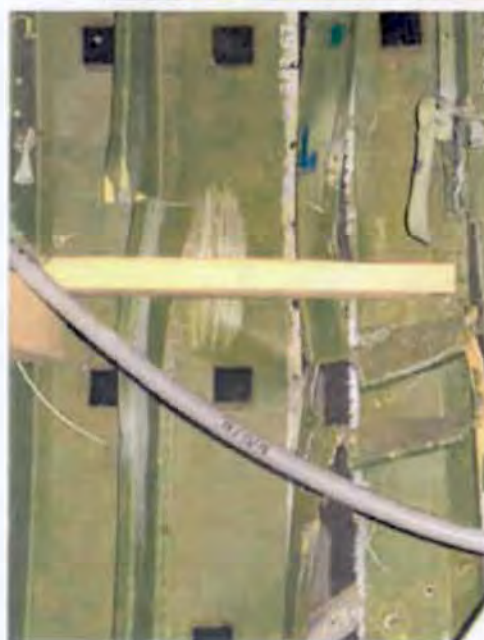
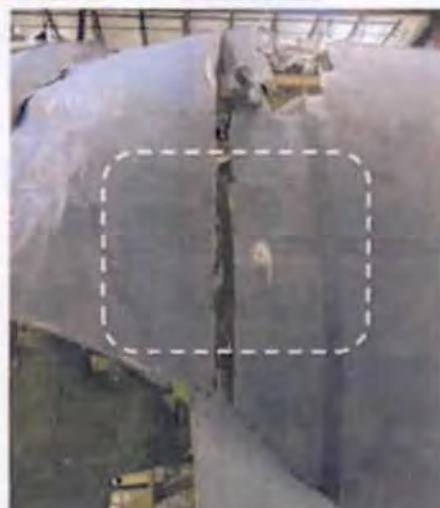
Figure 13: Center Fuselage Section Right Side

125. Just aft of the point where P2B4 impacted the starboard interior support beam, the center fuselage starboard side skin separated along FS 390.33 up toward the starboard side longeron support structures. [Encls (13), (21), (22)]

Impact damage from blade impacting right sidewall
near WL200 between STA 377-397

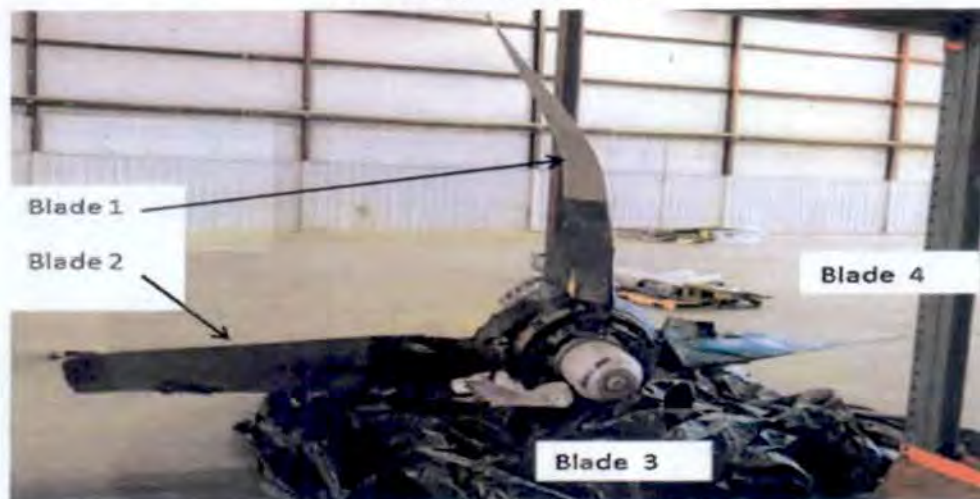
Figure 10: Propeller Assembly Three

128. When propeller three embedded in the upper section of the fuselage, it pushed the upper structure backward, resulting in an accordion-like buckling failure of RBL 20 longeron. [Encl (21)]

129. This intrusion of propeller three caused overload failure of the RBL 61 longeron to each side of the point of impact, and the propeller continued upward to exit approximately 10 inches below RBL 20 longeron. [Encl (21)]

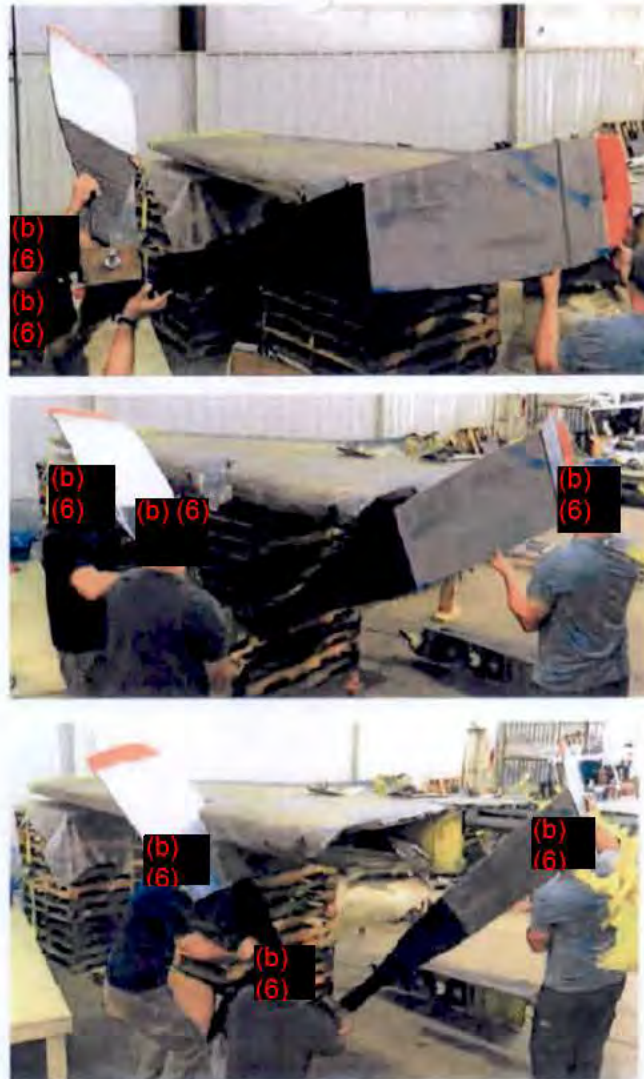
Figure 11: Reconstruction of Propeller Three Impact to Horizontal Stabilizer

134. Propeller three impacted the starboard horizontal stabilizer and caused a significant portion of the stabilizer to separate from the aircraft. [Encls (13), (21), (22)]

135. Blade one of propeller three impacted the starboard side horizontal stabilizer at horizontal stabilizer station (HSS) 130 oriented such that the end of the airfoil tip inserted into to the leading edge, pushing rear through the stabilizer and rotating downward upon contact with the front beam assembly, slicing through the lower surface. [Encl (21)]

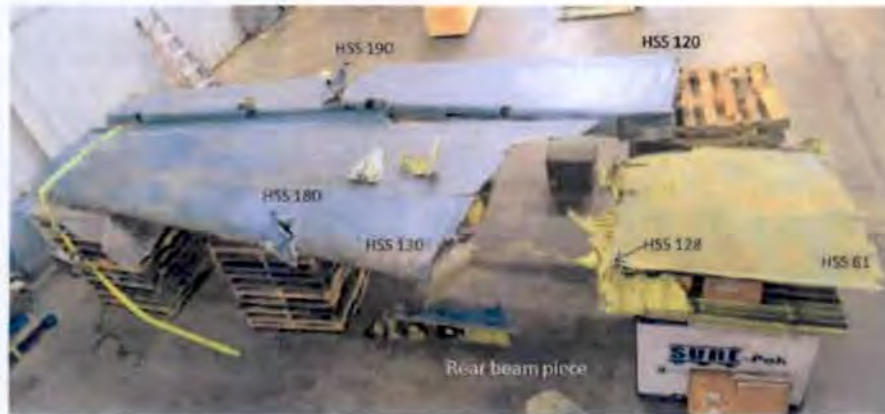
Figure 12: Horizontal Stabilizer

137. The right hand outer section of the starboard horizontal stabilizer, as well as the right hand elevator, both liberated as a direct consequence of impact from propeller three. [Encl (21)]

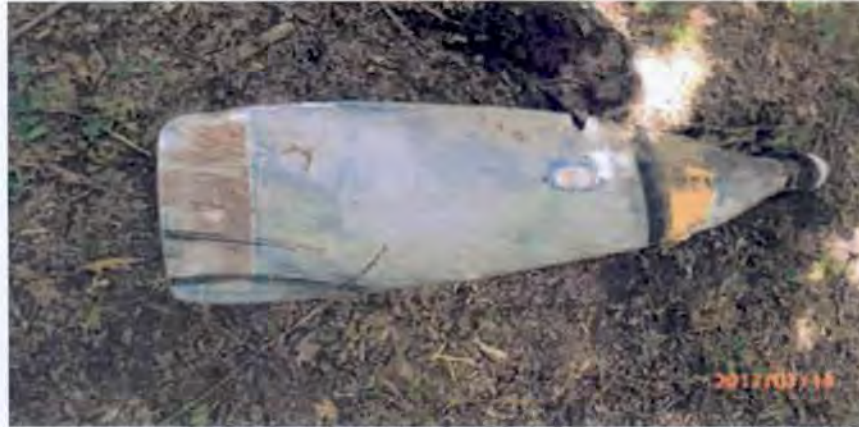
Figure 13: P2B4

145. A post-mishap inspection showed that P2B4 had an intergranular crack (IGC) and radial crack in the vicinity of the bushing bore of the propeller. This developed from corrosion pitting and intergranular cracking that was present and not removed during the last overhaul performed by WR-ALC in September 2011. [Encls (22), (30), (31)]

146. Bushing and taper bore inspections of P2B4 revealed the following discrepancies: bushing epoxy primer was not present; permatreat was not present; and substantial clustered active corrosion was found with fluorescent penetrant inspection (FPI), and confirmed with an eddy current inspection in the bushing bore area of the blade taper bore. [Encls (22), (27)]

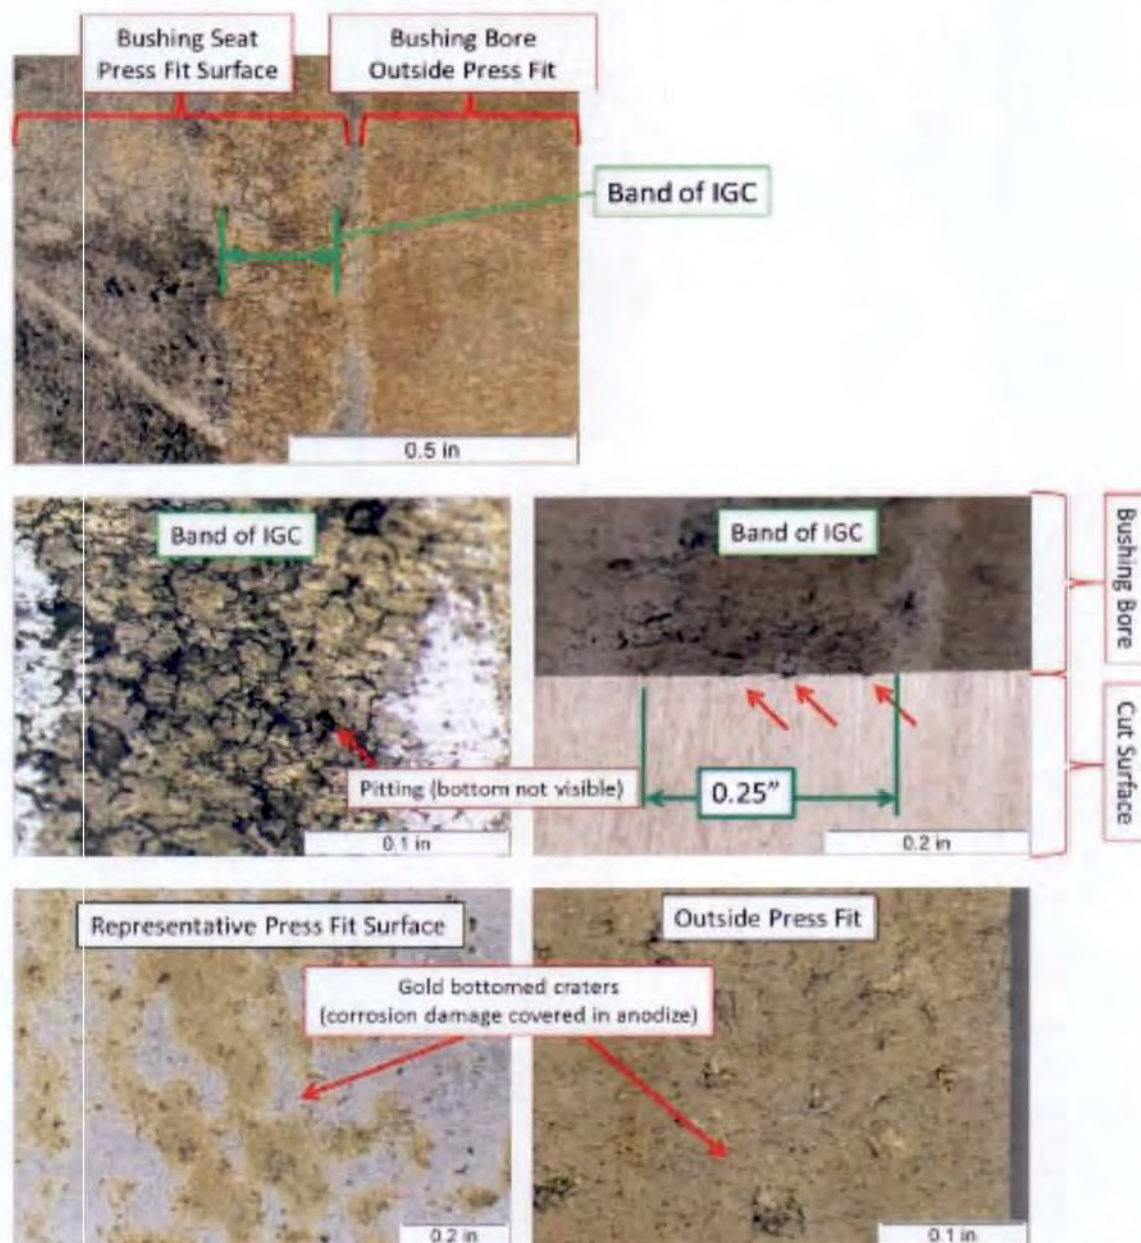
Figure 14: Bushing Bore Surfaces - Note Changing Scale Bars

147. Active corrosion and the resulting IGC were found in the bushing bore area of the taper bore. [Encls (22), (27)]

148. Anodize coating was found extending into corrosion pitting and IGC. [Encls (22), (27)]

151. Presence of anodize in the corrosion pits and IGC proves the corrosion was present and not removed at the last overhaul in August of 2011. [Encls (22), (27)]

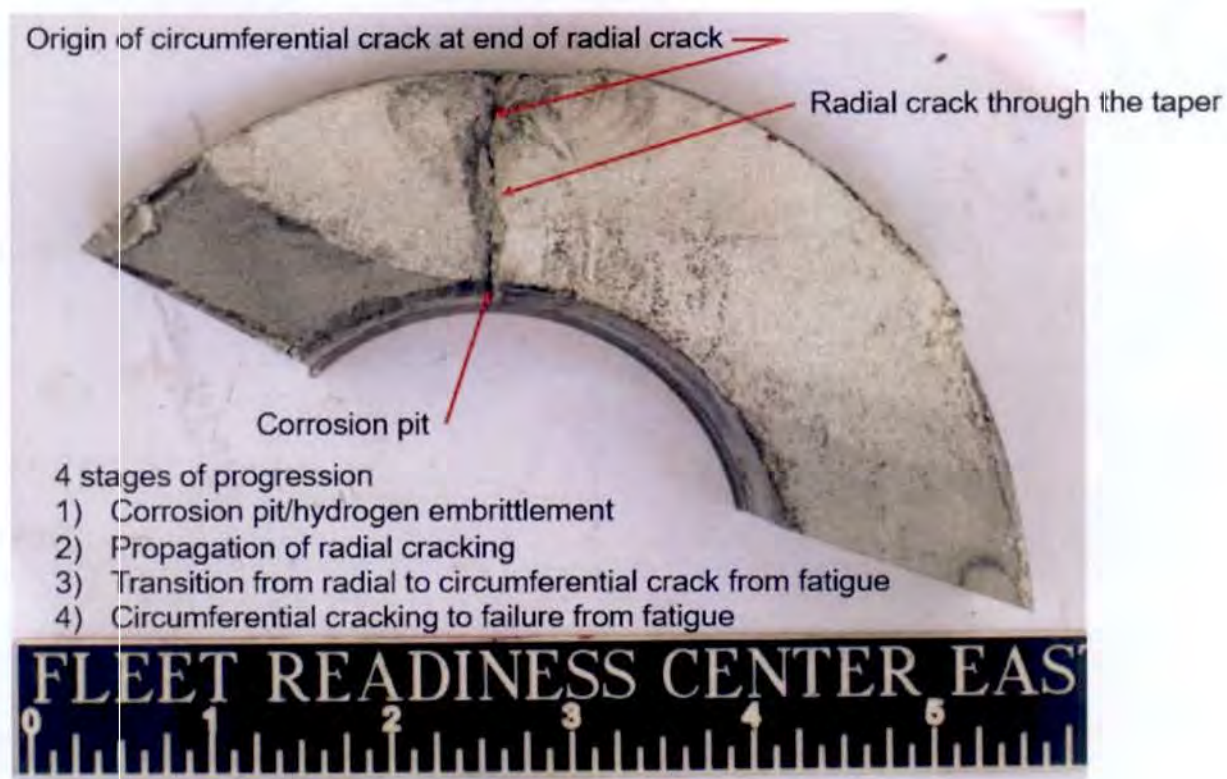
Figure 15: Radial Crack Root Cause

152. The presence of the clustered active corrosion and IGC initiated the formation of the intergranular radial crack in blade four. [Encls (22), (27)]

153. This intergranular radial crack in P2B4 had grown to a total of 2.7 inches in length along the interior taper bore of the blade, extending 1.25 inches beyond the bushing. [Encls (22), (27), (30)]

155. The radial crack had grown outward through 64 percent of the shank wall section until it was 0.45 inches from the outer diameter at the time P2B4 liberated on 10 July 2017. [Encls (22), (27), (30)]

159. The intergranular radial crack in blade four, which ultimately was the root cause of this catastrophic mishap, developed and matured from corrosion pitting and IGC that was not removed during the last blade overhaul in the fall of 2011. [Encls (22), (27), (30)]

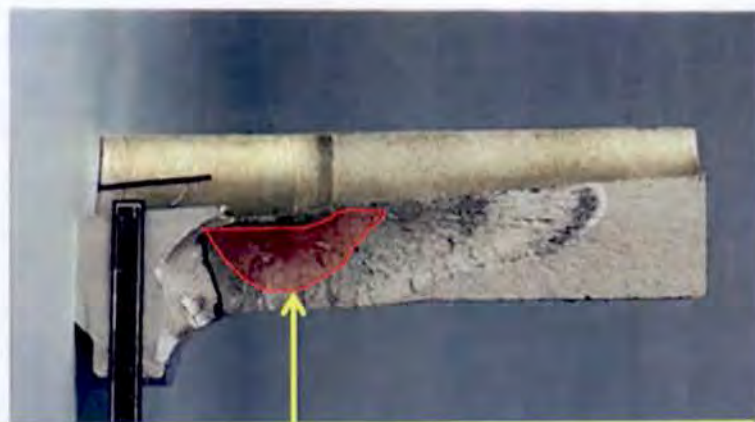
Approximate location of intergranular band
Coincident with outboard tip of bushing

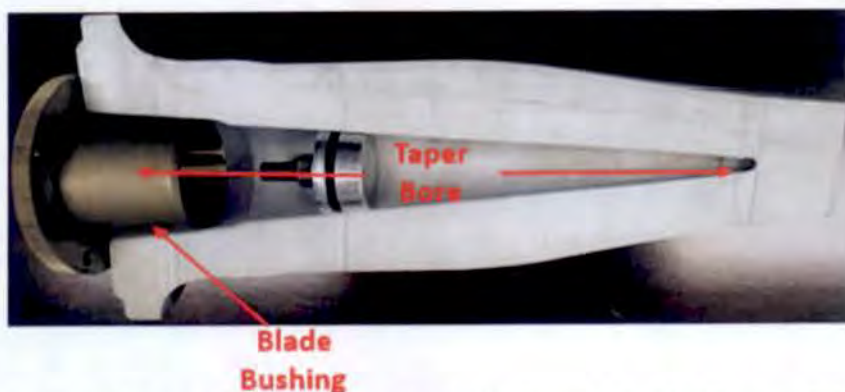
Figure 18: Taper Bore Side View with Blade Bushing

289. An eddy current inspection can only detect cracks which are within 0.017 inches of the surface of this particular propeller blade material. [Encls (33), (34)]
