CAUSE OF COLLISION

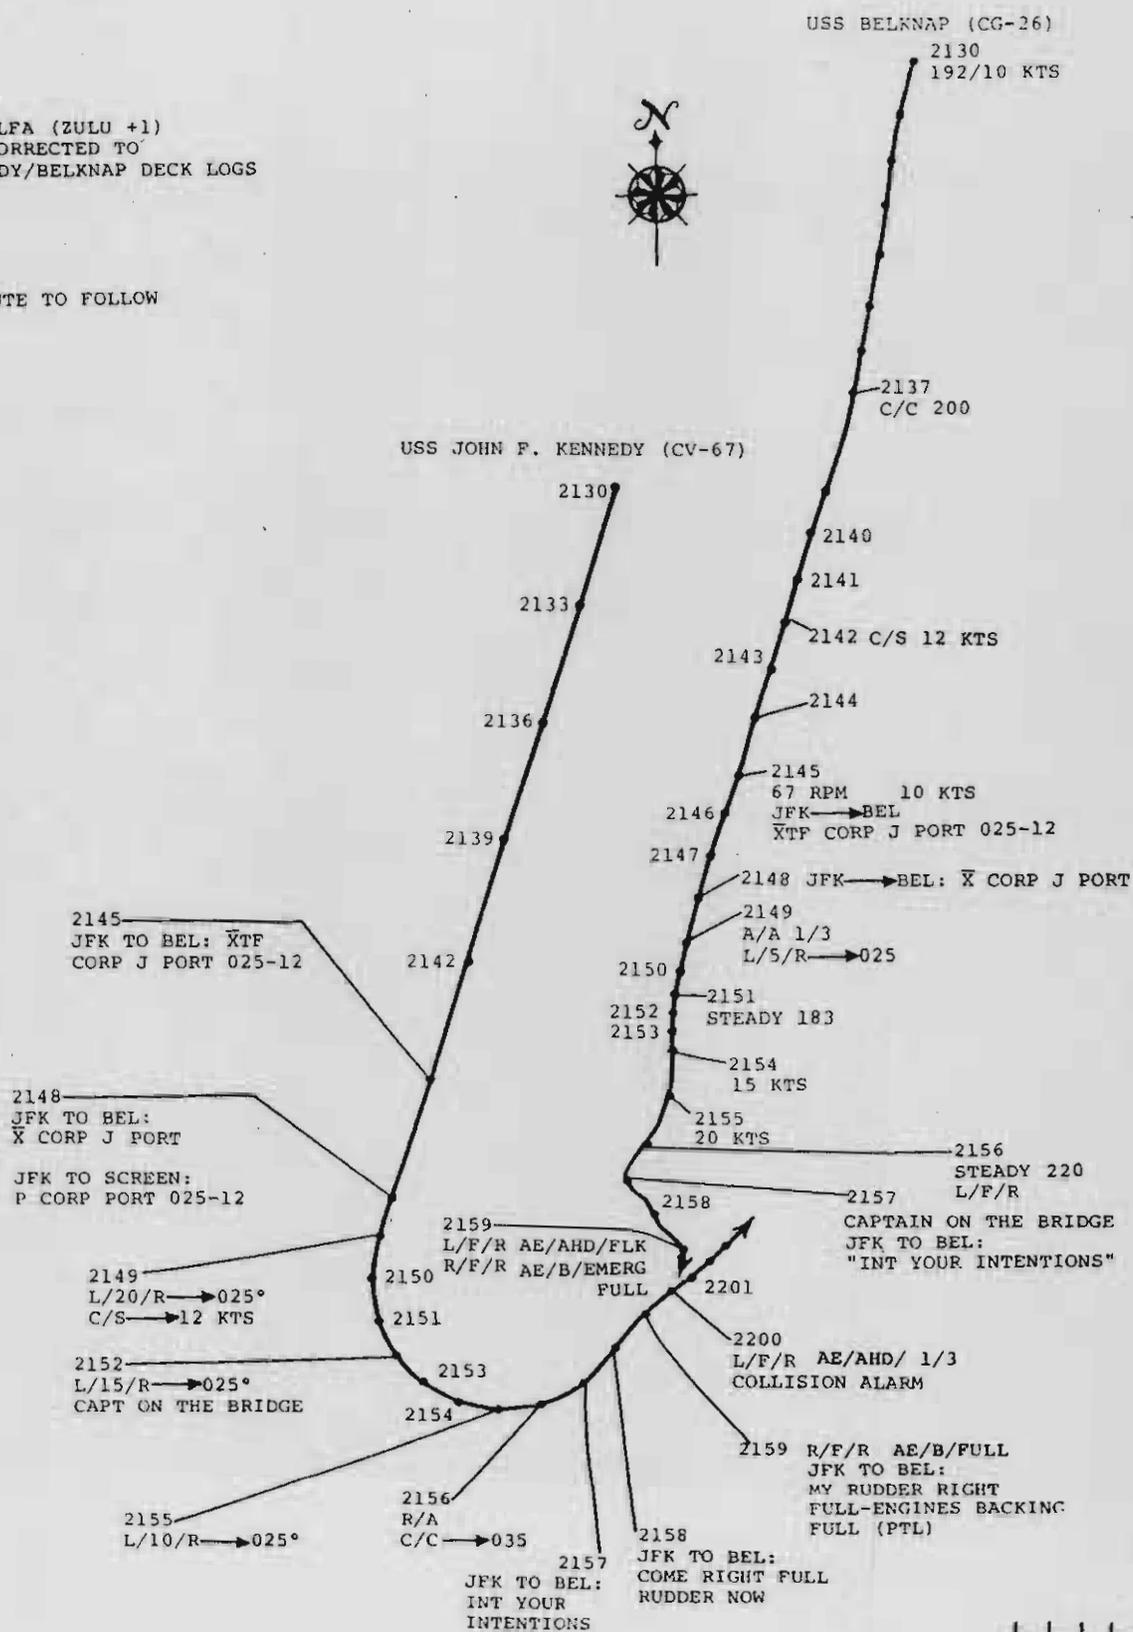
Figure I

furnishes a verbal interpretation of Figure 1. The facts and opinions relating to the exact time and events are to be found previous to and subsequent to this narrative and figure.

a. BELKNAP was on station generally maintaining a course of 200 degrees prior to the delayed executive signal CORPEN J PORT 025-12. The signal was given in NUCO and was "broken" properly by BELKNAP bridge and CIC personnel. At the execution of the signal, J.F. KENNEDY came left toward the ordered new course 025 degrees and increased shaft turns for speed 12 KTS. BELKNAP slowed to turns for 5 KTS and placed her rudder left 5 degrees in an initial repositioning effort. This rudder angle was slowly effective and the ship's head came left to 183 degrees where BELKNAP OOD felt that "this was taking too long." BELKNAP steadied on 185 degrees and the OOD evidenced his first doubt as to the target angle of J.F. KENNEDY. BELKNAP CIC recommended Right Full Rudder over the JL sound-powered phone circuit at this time, after realizing that the CPA would be close. The bridge JL talker was not effective in conveying these recommendations.

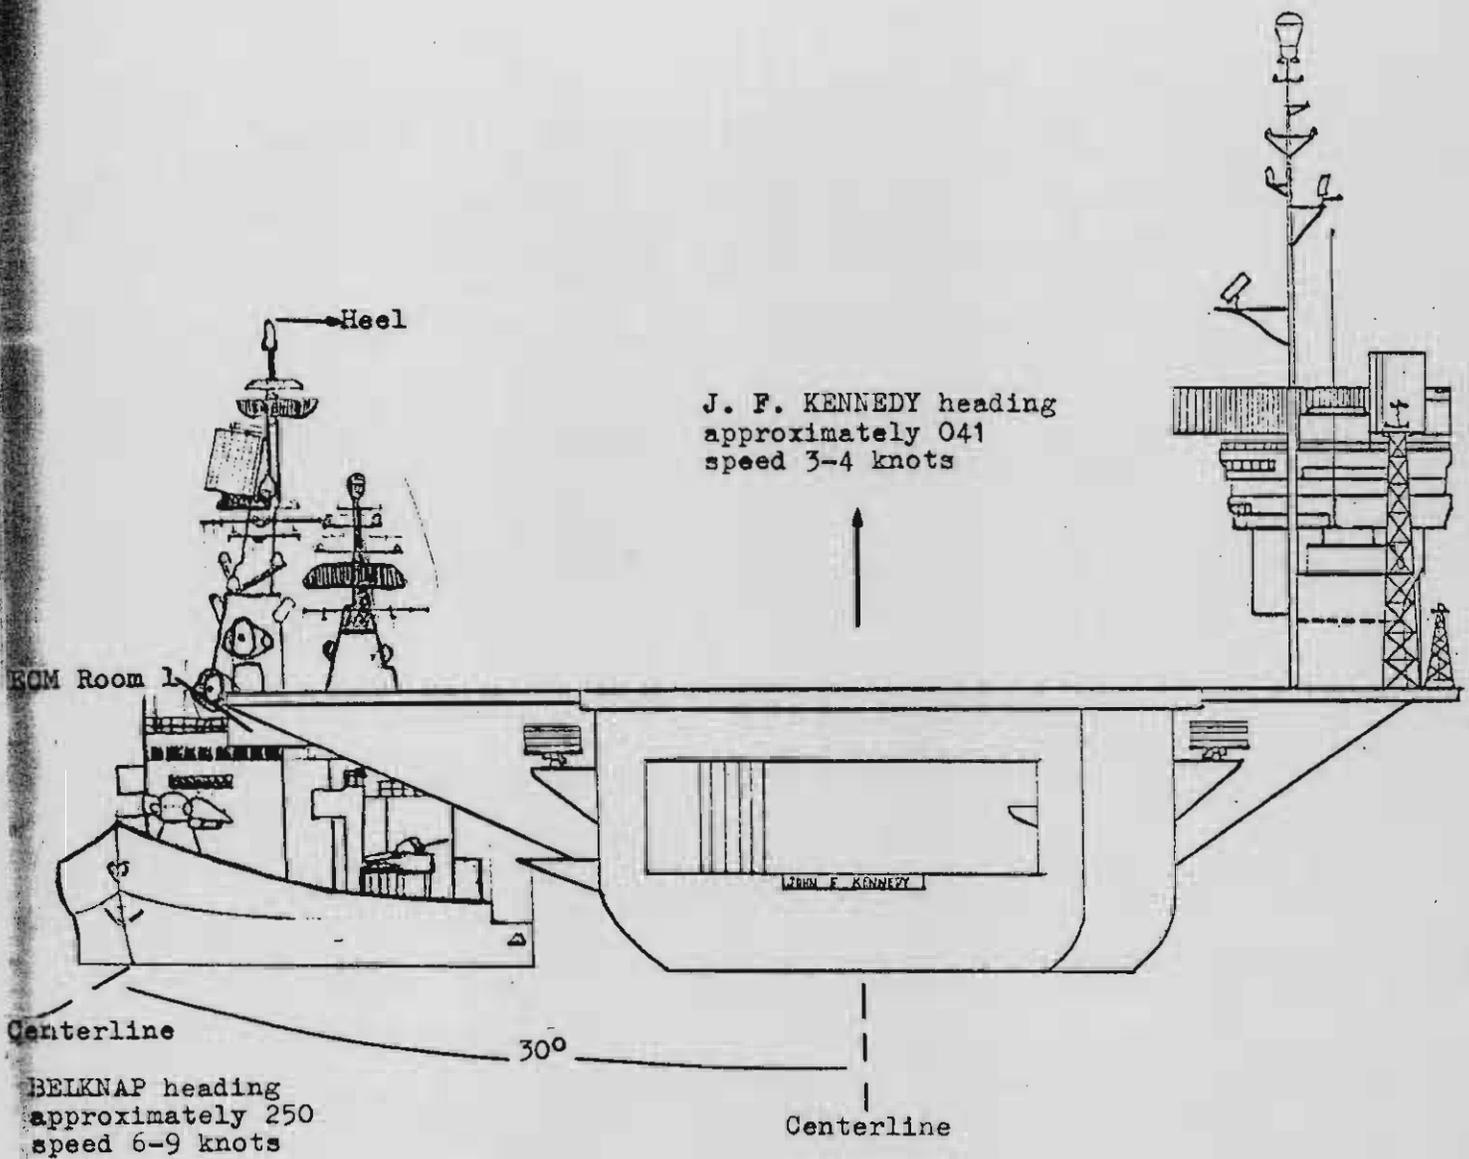
Figure II

J. F. KENNEDY turning right, stern swinging left
 BELKNAP turning right, stern swinging left
 Relative speed 10-12 knots.

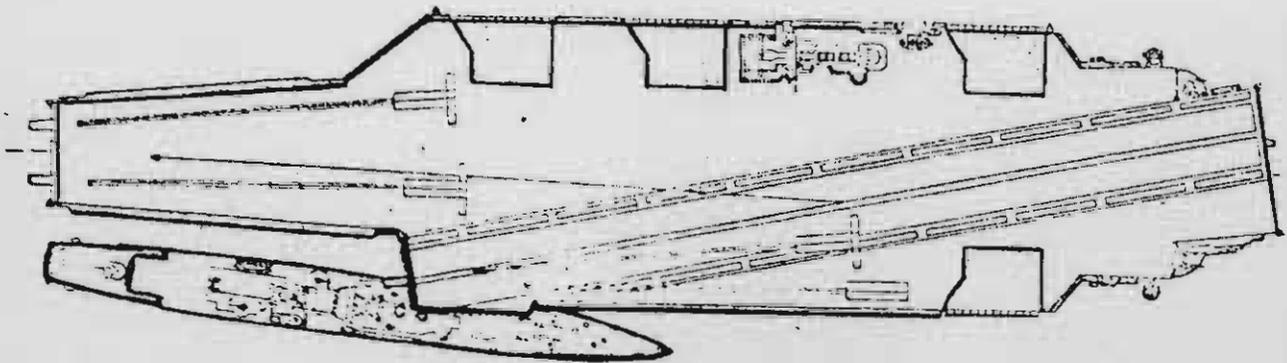
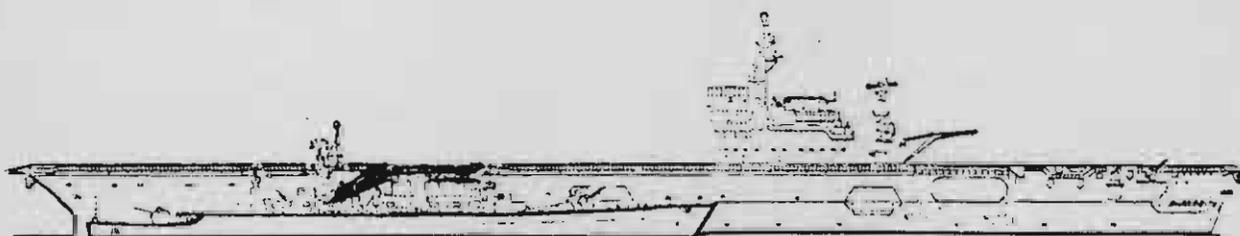
Figure III

First flash of fire came from switchbox in BELKNAP CIC as the pilot house and CIC were laid open.

Initial contact occurred at Frame 78 J. F. KENNEDY, Frame 73 BELKNAP, BELKNAP turning hard with angle of incidence of approximately 30° .

View adjusted to reflect approximate position as determined from line of destruction and coincides with normal swing of BELKNAP.

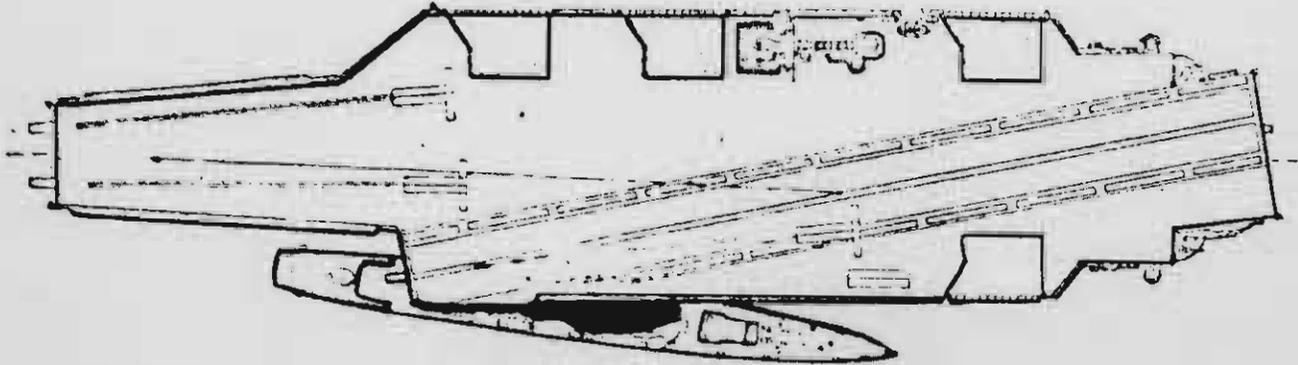
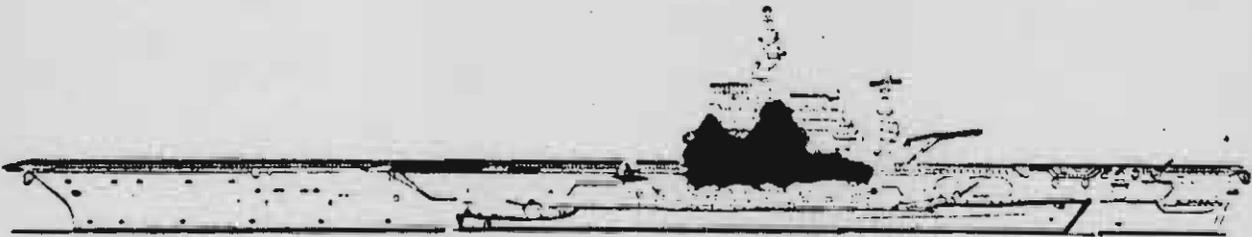
Figure IV

As BELKNAP proceeded down J. F. KENNEDY's port side, JP-5 Stations 8 and 12 poured about 1500 gallons of JP-5 onto BELKNAP, which ignited.

Flight deck crewmen of J. F. KENNEDY were pouring light water from an MB-5 onto BELKNAP.

The superstructure of BELKNAP was laid open and JP-5 poured into the uptakes of the forward and after fire rooms.

BELKNAP crewmen could look up and see J. F. KENNEDY looming above them.

View reflects the "stopped" position of BELKNAP. The drag of the collision would tend to pull the bow to the left as seen above.

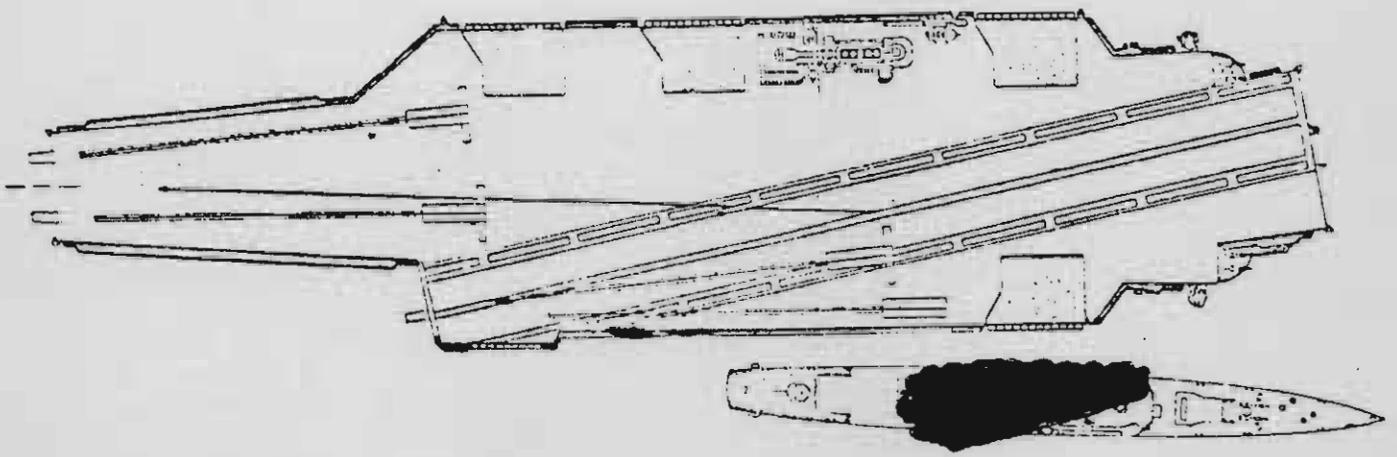
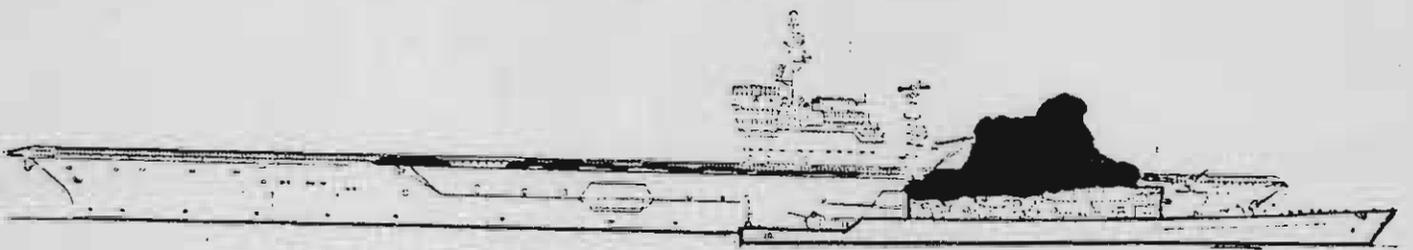
Figure V

As the ships broke clear
BELKNAP was already fighting fires
J. F. KENNEDY engineering spaces were
inundated with heavy black smoke

BELKNAP had come to all stop.
all engineering spaces were evacuated
