USS RANGER [CVA-61]
FPO SAN FRANCISCO 96601

Subj: Damage (possible sabotage) in Engineering Spaces of
USS RANGER (CVA 61); supplemental investigation of

- From: Commander Carrier Division THREE
 To: Commander Naval Air Force, U.S. Pacific Fleet
- Subj: Damage (possible sabotage) in Engineering Spaces of USS RANGER (CVA 61); supplemental investigation of
- Ref: (a) COMCARDIV THREE ltr ser 023 of 18 Jul 1972
 (b) NAVSHIPS Technical Manual
 (c) NAVINSERVO Report Control #07-08-72N12-AL77-6 UNA of 2 Aug 1972 (NOTAL)
- Encl: (1) Summary of supplemental unsworn statement of LCDR [redacted], USN
 (2) Summary of supplemental unsworn statement of CDR [redacted], USN
 (3) Summary of supplemental unsworn statement of CAPT [redacted], USN
 (4) Charge Sheet in case of [redacted], dated 2 Aug 1972, with Additional Charge Sheet dated 23 Aug 1972
 (5) Summary of supplemental unsworn statement of CDR [redacted], USN
 (6) USS RANGER INST 5500.2A of 11 Aug 1972
 (7) NISO Report ser 827 of 7 Aug 1972

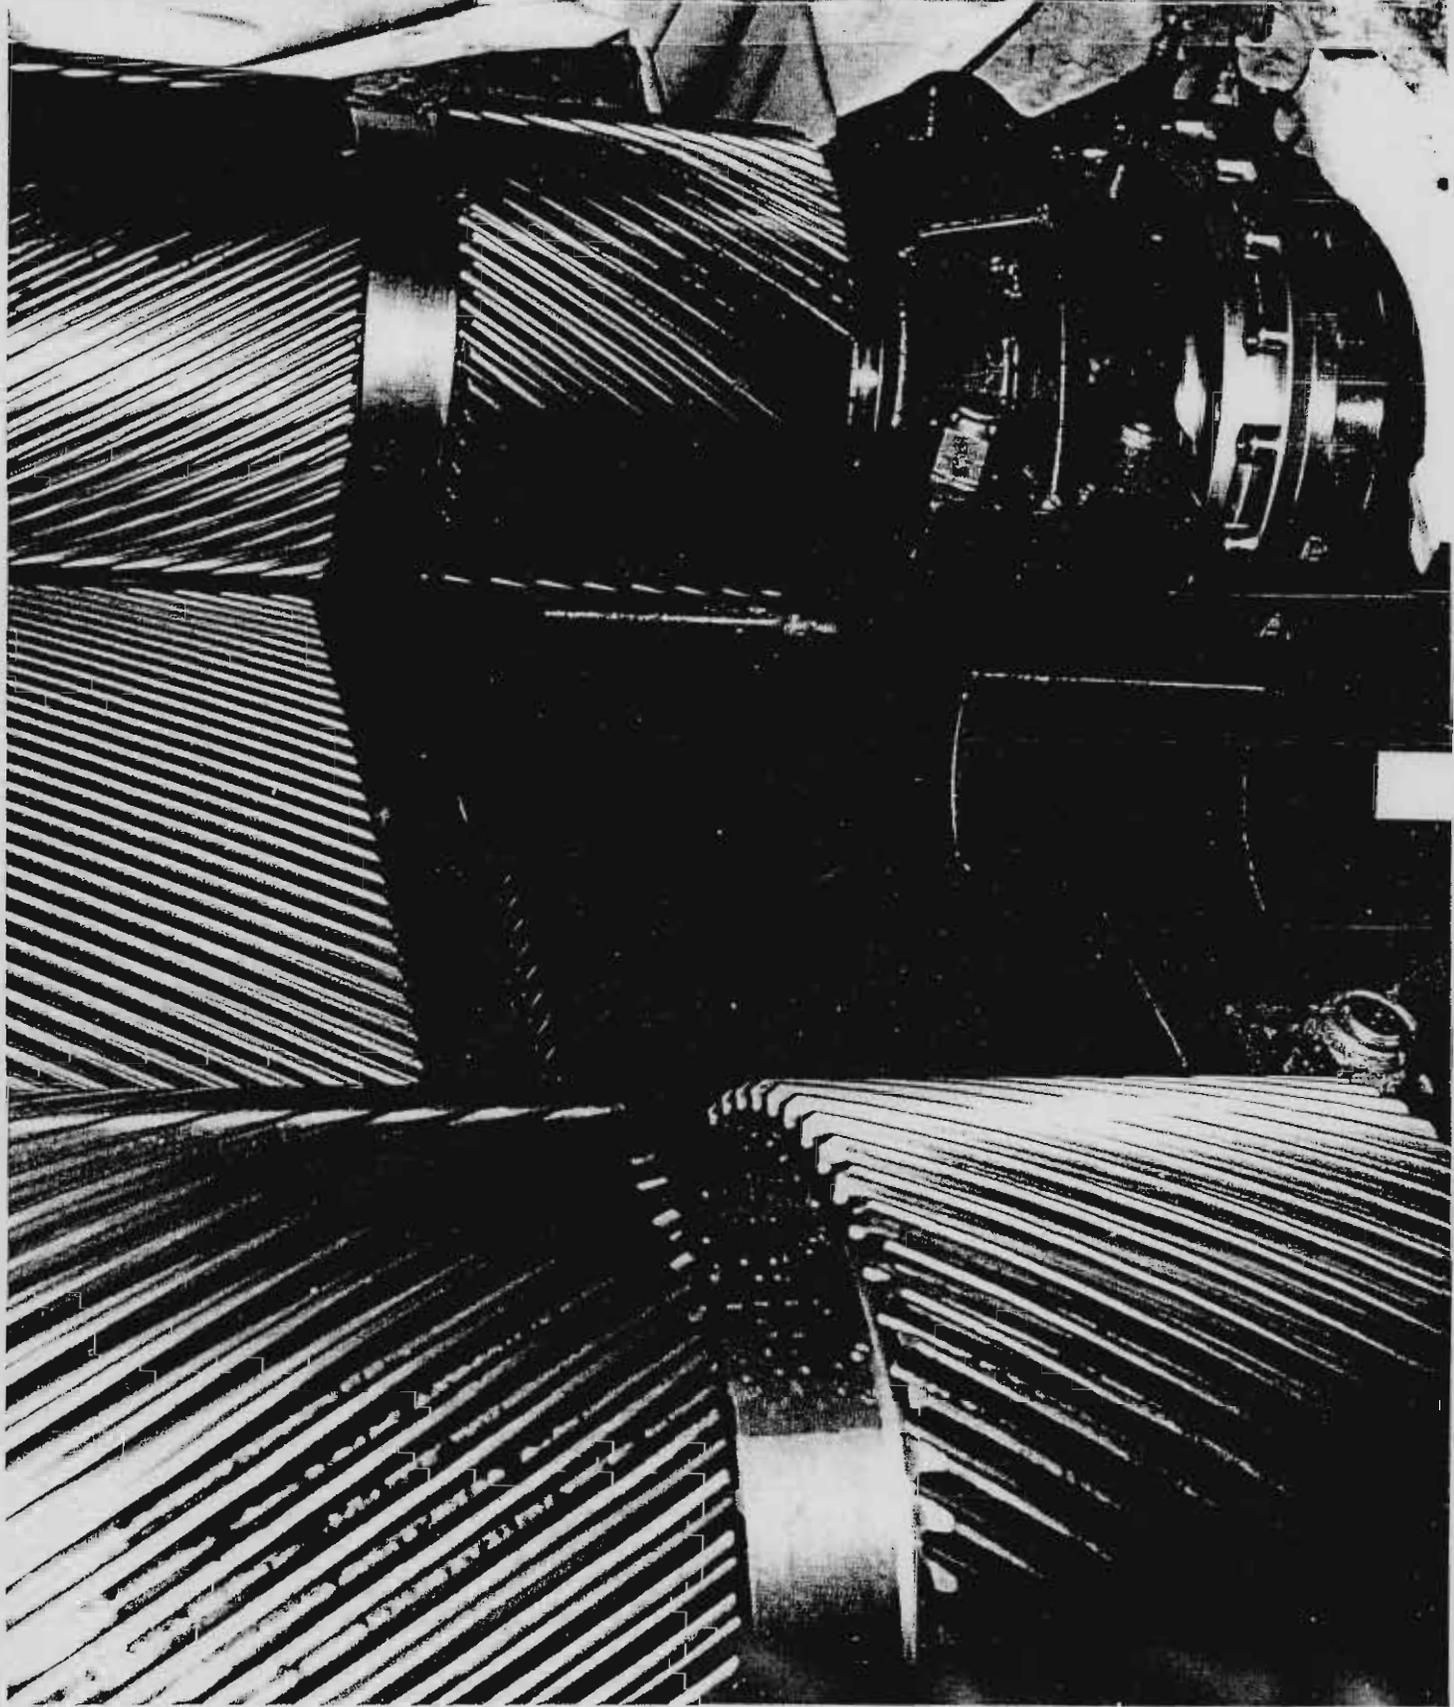
ENCLOSURE (34)

Looking down through the upper aft inspection port before quadrant cover was removed. Camera physically positioned slightly inside inspection port. Object shown is threaded bolt approx 12" X 1 1/2".

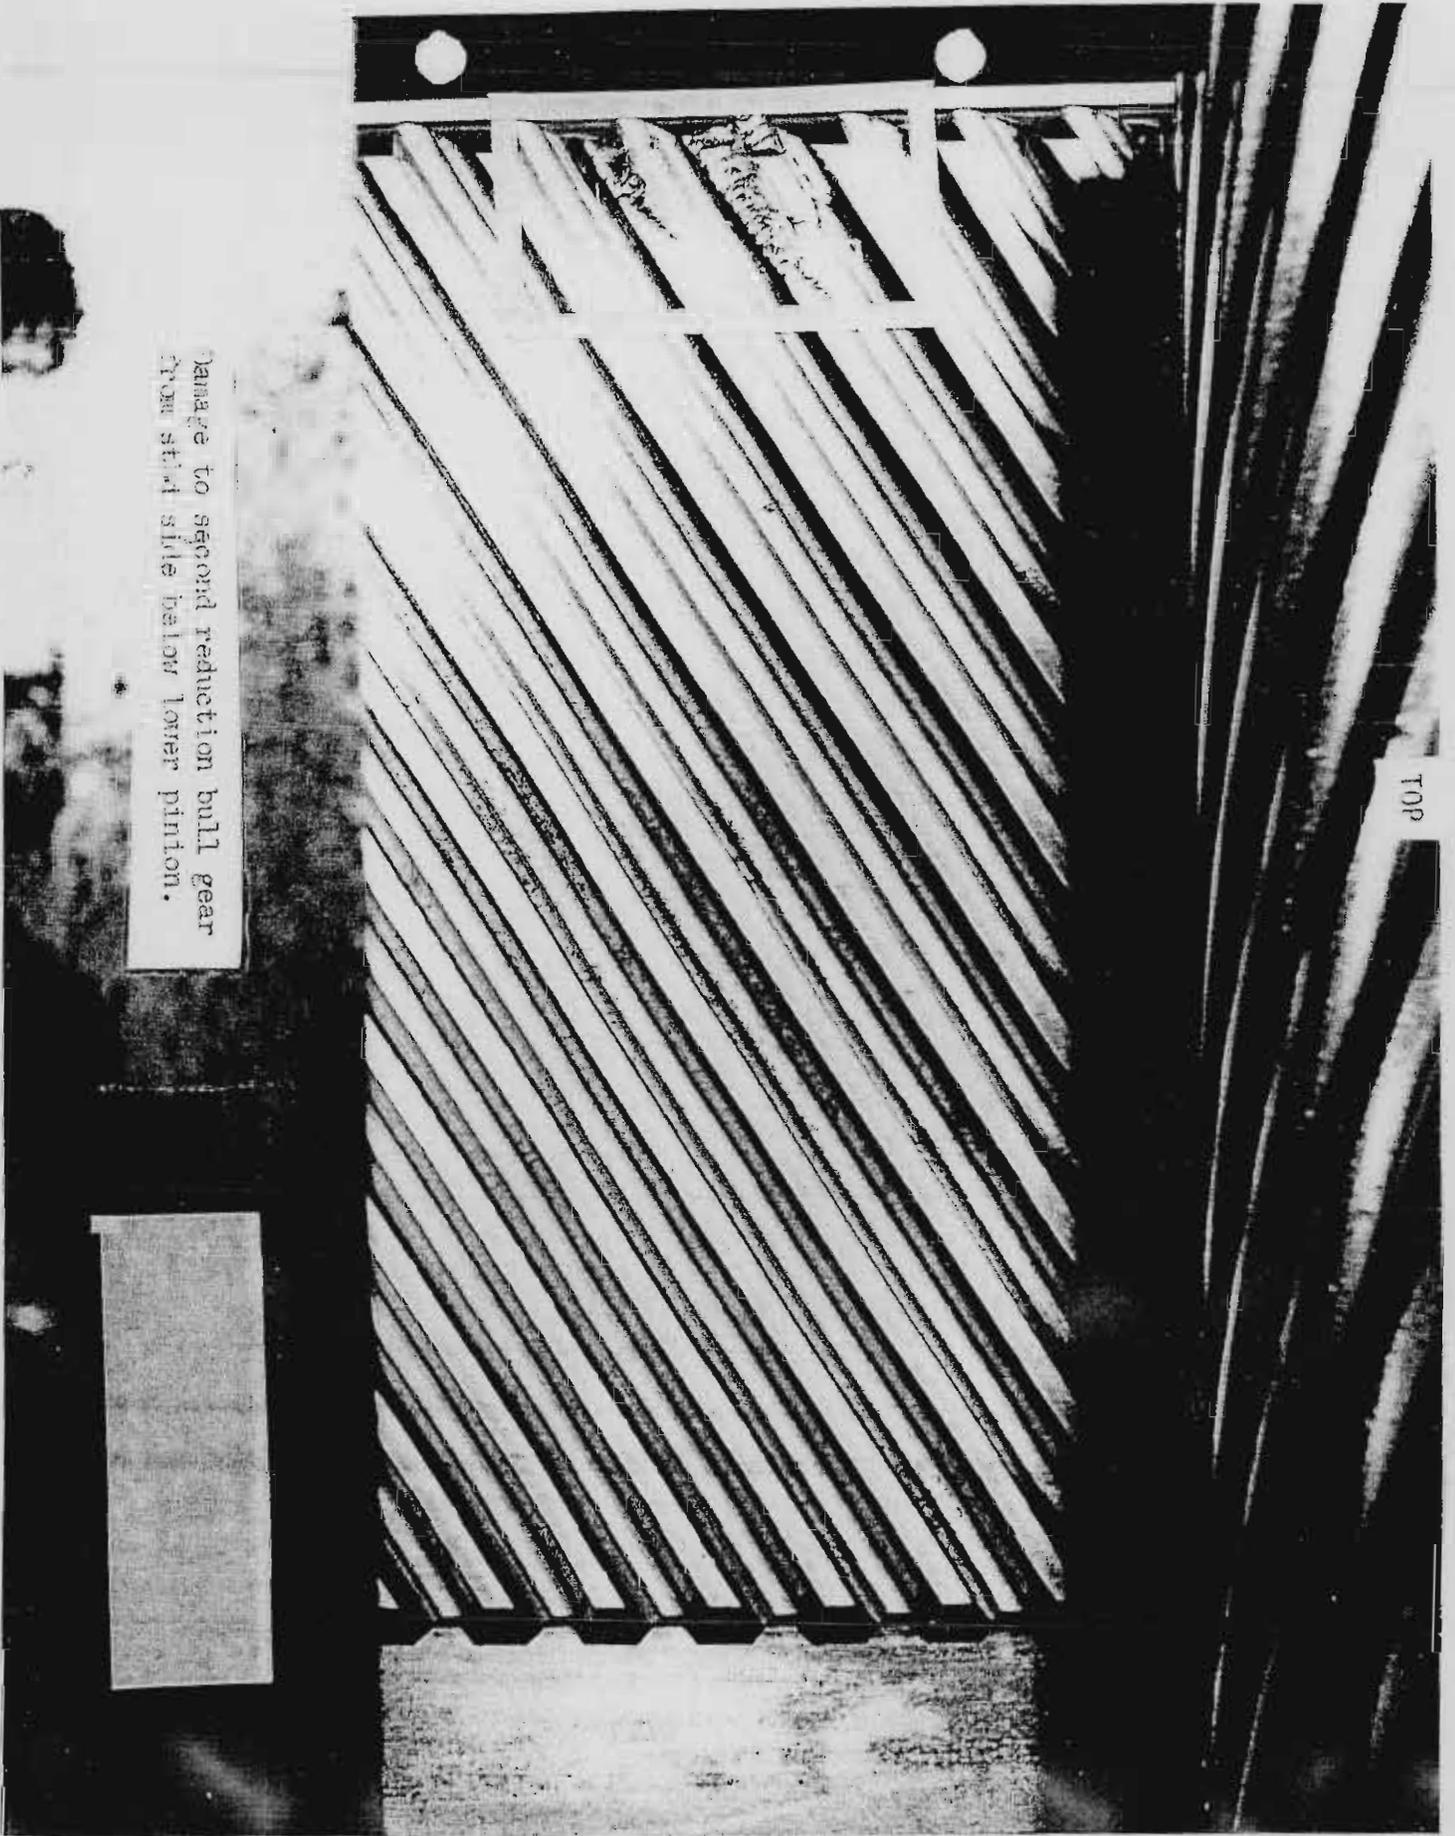
Damage to second reduction bull gear
from shift side below lower pinion.
