UNITED STATES MARINE CORPS
MARINE FORCES RESERVE
2000 OPELOUSAS AVE.
NEW ORLEANS LA 70114

Subj: COMMAND INVESTIGATION INTO THE CLASS A AVIATION MISHAP WITHIN
MARINE AERIAL REFUELER TRANSPORT SQUADRON 452 ON 10 JULY 2017

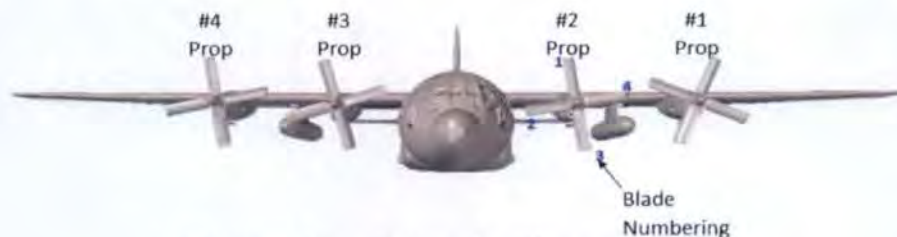
Figure 3: Frontal View of C-130

107. This impact caused the skin of the aircraft to separate along the starboard side. The energy transferred from P2B4's impact through the structure of the airframe also caused an overload condition of propeller three's drive shaft. This resulted in its associated reduction gearbox assembly (RGA) failing and the separation of propeller three from the aircraft. Propeller three then momentarily embedded into the upper right section of the fuselage. After which, it continued over the aft starboard section of the fuselage and impacted the starboard horizontal stabilizer separating a significant portion of the stabilizer from the aircraft. [Encls (13), (21), (22)]

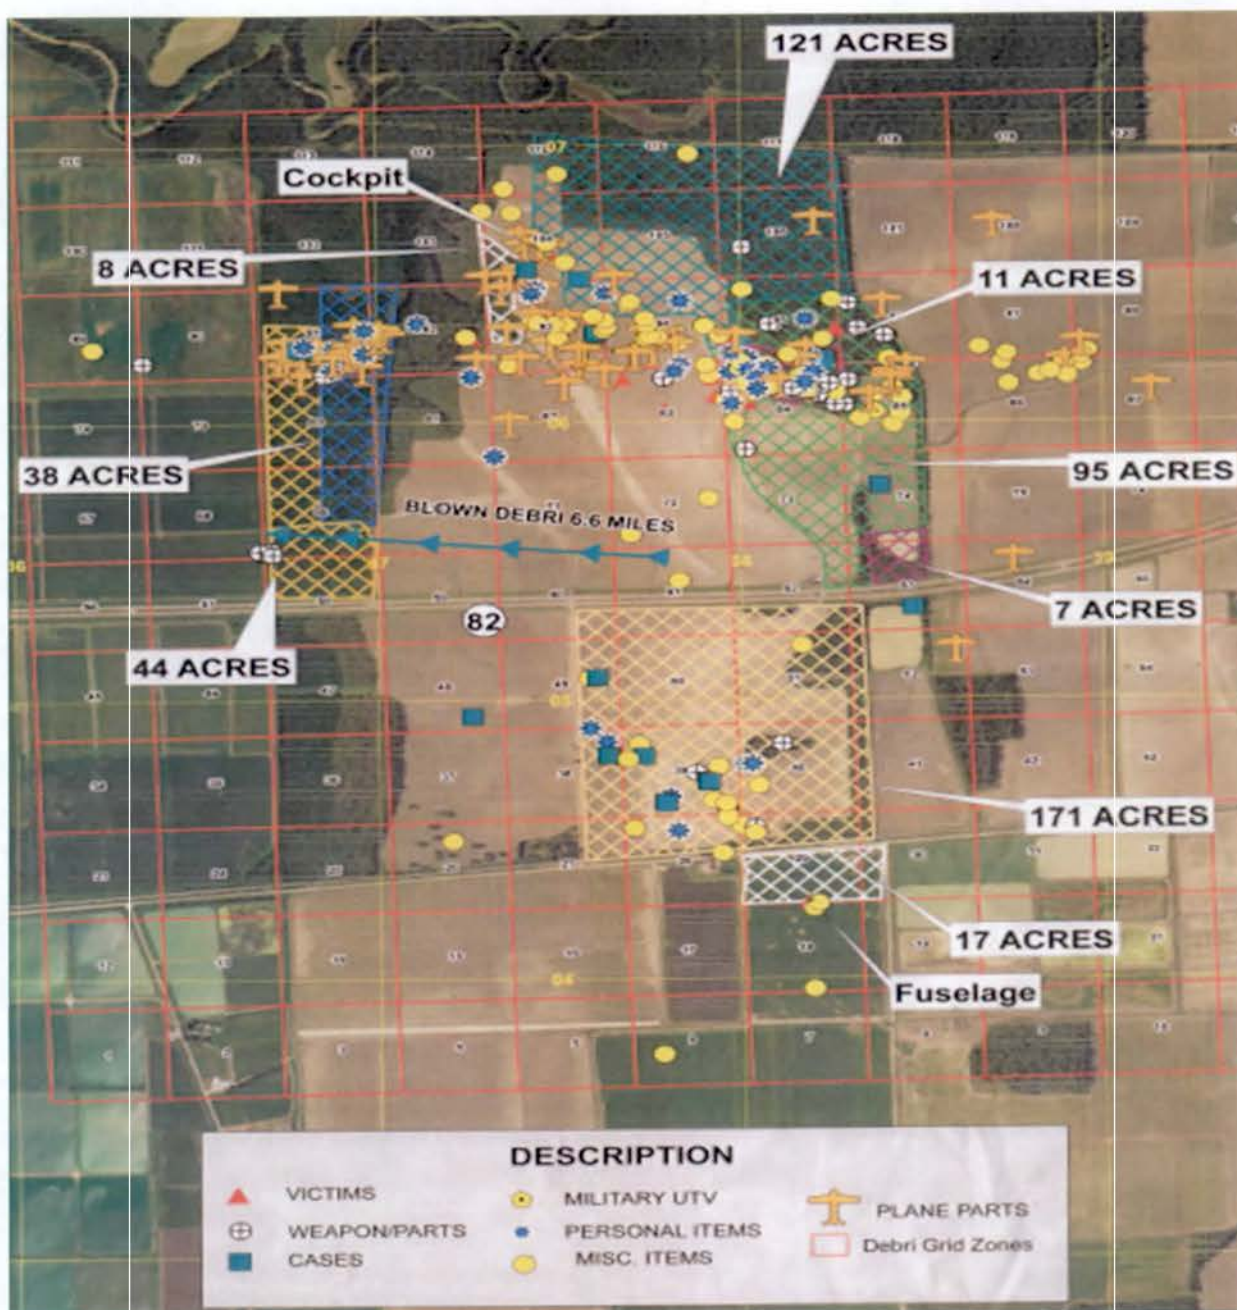
Figure 4: Aerial Photo of Crash Site

115. Fire damage in the NDF was concentrated in the area of the impact site of the cockpit. [Encl (13)]

119. Fire damage was significant at the SDF. [Encl (13)]

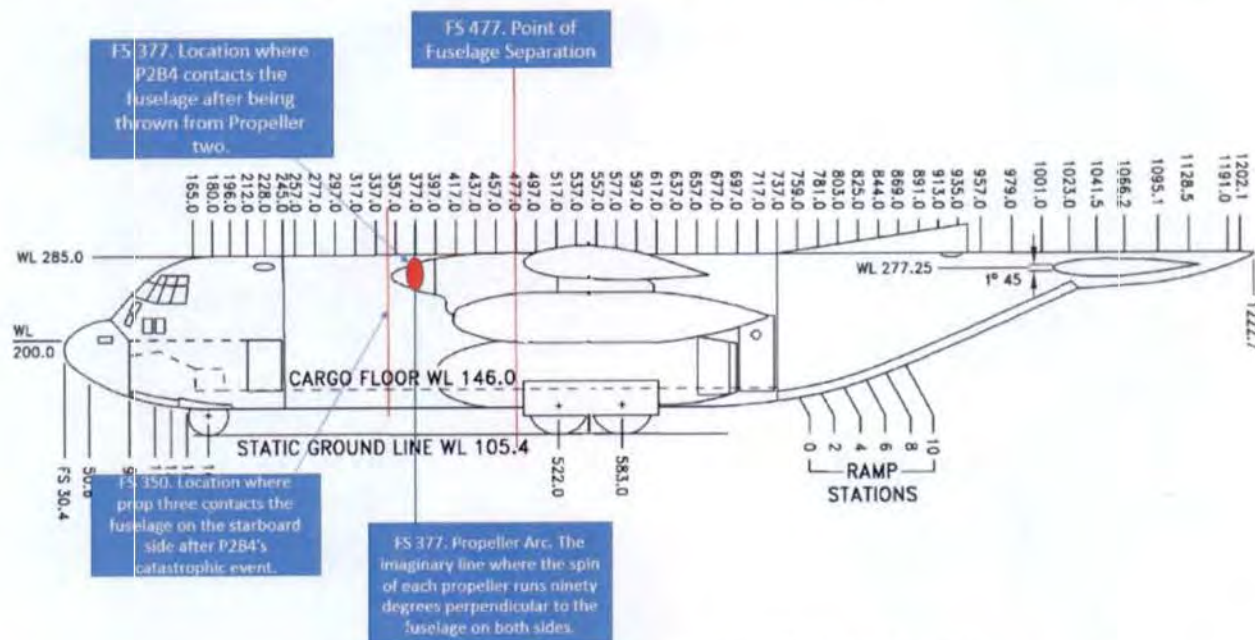
Figure 5: Side Schematic of Key Areas

121. After departure, P2B4 sliced through the port side of the fuselage at FS 377 slightly aft of the propeller arc plane upon entry in a near vertical orientation. This deteriorated the left side longeron support structures as the tip cut 36 inches below left butt line (LBL) 61 and the root end of the blade impacted 19 inches above LBL 61. P2B4 then passed unobstructed through the MAC interior, and did not exit the airframe but rather impacted the interior starboard side of the cargo compartment where it remained until cargo compartment separation. [Encls (13), (21), (22)]

122. P2B4's intrusion resulted in an overload failure of the LBL 61 longeron on both sides of the impact point at FS 377. [Encl (21)]

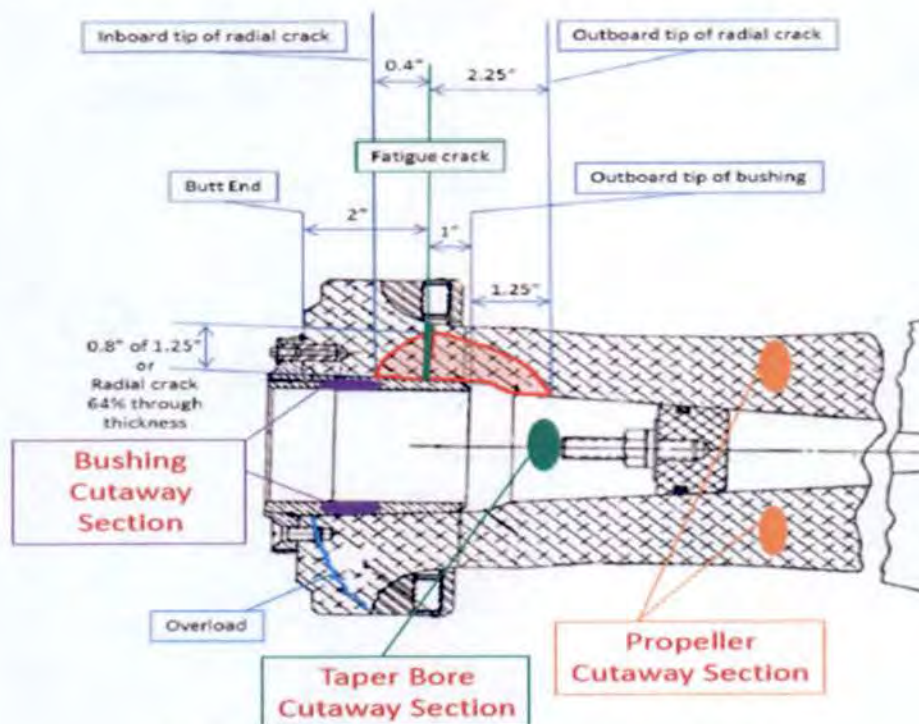
Figure 16: P2B4 Cutaway Breakdown

145. A post-mishap inspection showed that P2B4 had an intergranular crack (IGC) and radial crack in the vicinity of the bushing bore of the propeller. This developed from corrosion pitting and intergranular cracking that was present and not removed during the last overhaul performed by WR-ALC in September 2011. [Encls (22), (30), (31)]

153. This intergranular radial crack in P2B4 had grown to a total of 2.7 inches in length along the interior taper bore of the blade, extending 1.25 inches beyond the bushing. [Encls (22), (27), (30)]

155. The radial crack had grown outward through 64 percent of the shank wall section until it was 0.45 inches from the outer diameter at the time P2B4 liberated on 10 July 2017. [Encls (22), (27), (30)]

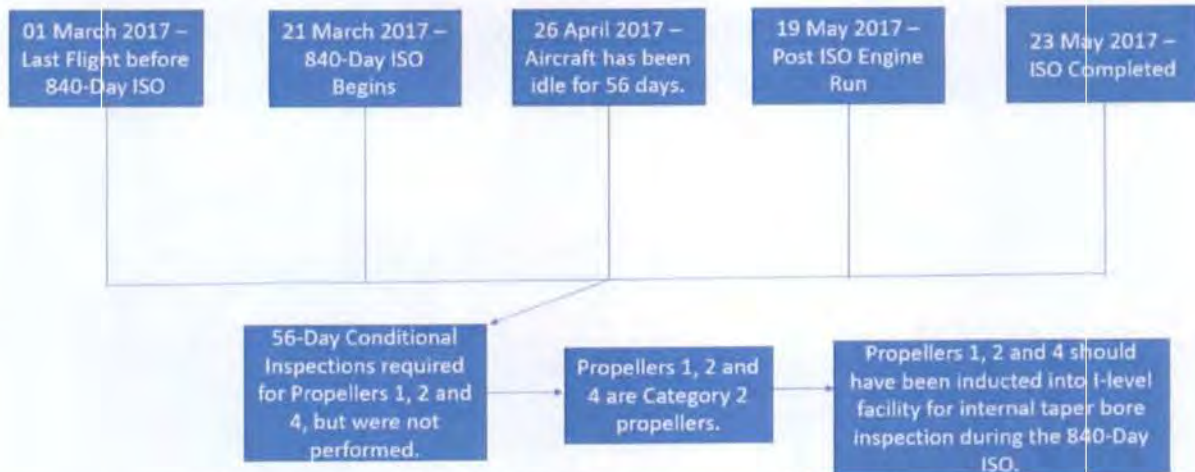
Figure 19: MAC Maintenance Inspection Timeline

312. Propellers one, two, and four remained on the MAC, and there is no evidence showing an off-wing eddy current inner taper bore inspection was performed on the MAC between the dates of 26 April 2017 and 24 May 2017. [Encls (42), (45)]
